**INITIAL GEOHYDROLOGICAL AND
GEOTECHNICAL INVESTIGATION REPORT
FOR THE DARVILL CONSTRUCTED WETLAND
– PIETERMARITZBURG – KWAZULU-NATAL**

INITIAL GEOHYDROLOGICAL AND GEOTECHNICAL INVESTIGATION REPORT FOR THE DARVILL CONSTRUCTED WETLAND – PIETERMARITZBURG – KWAZULU-NATAL

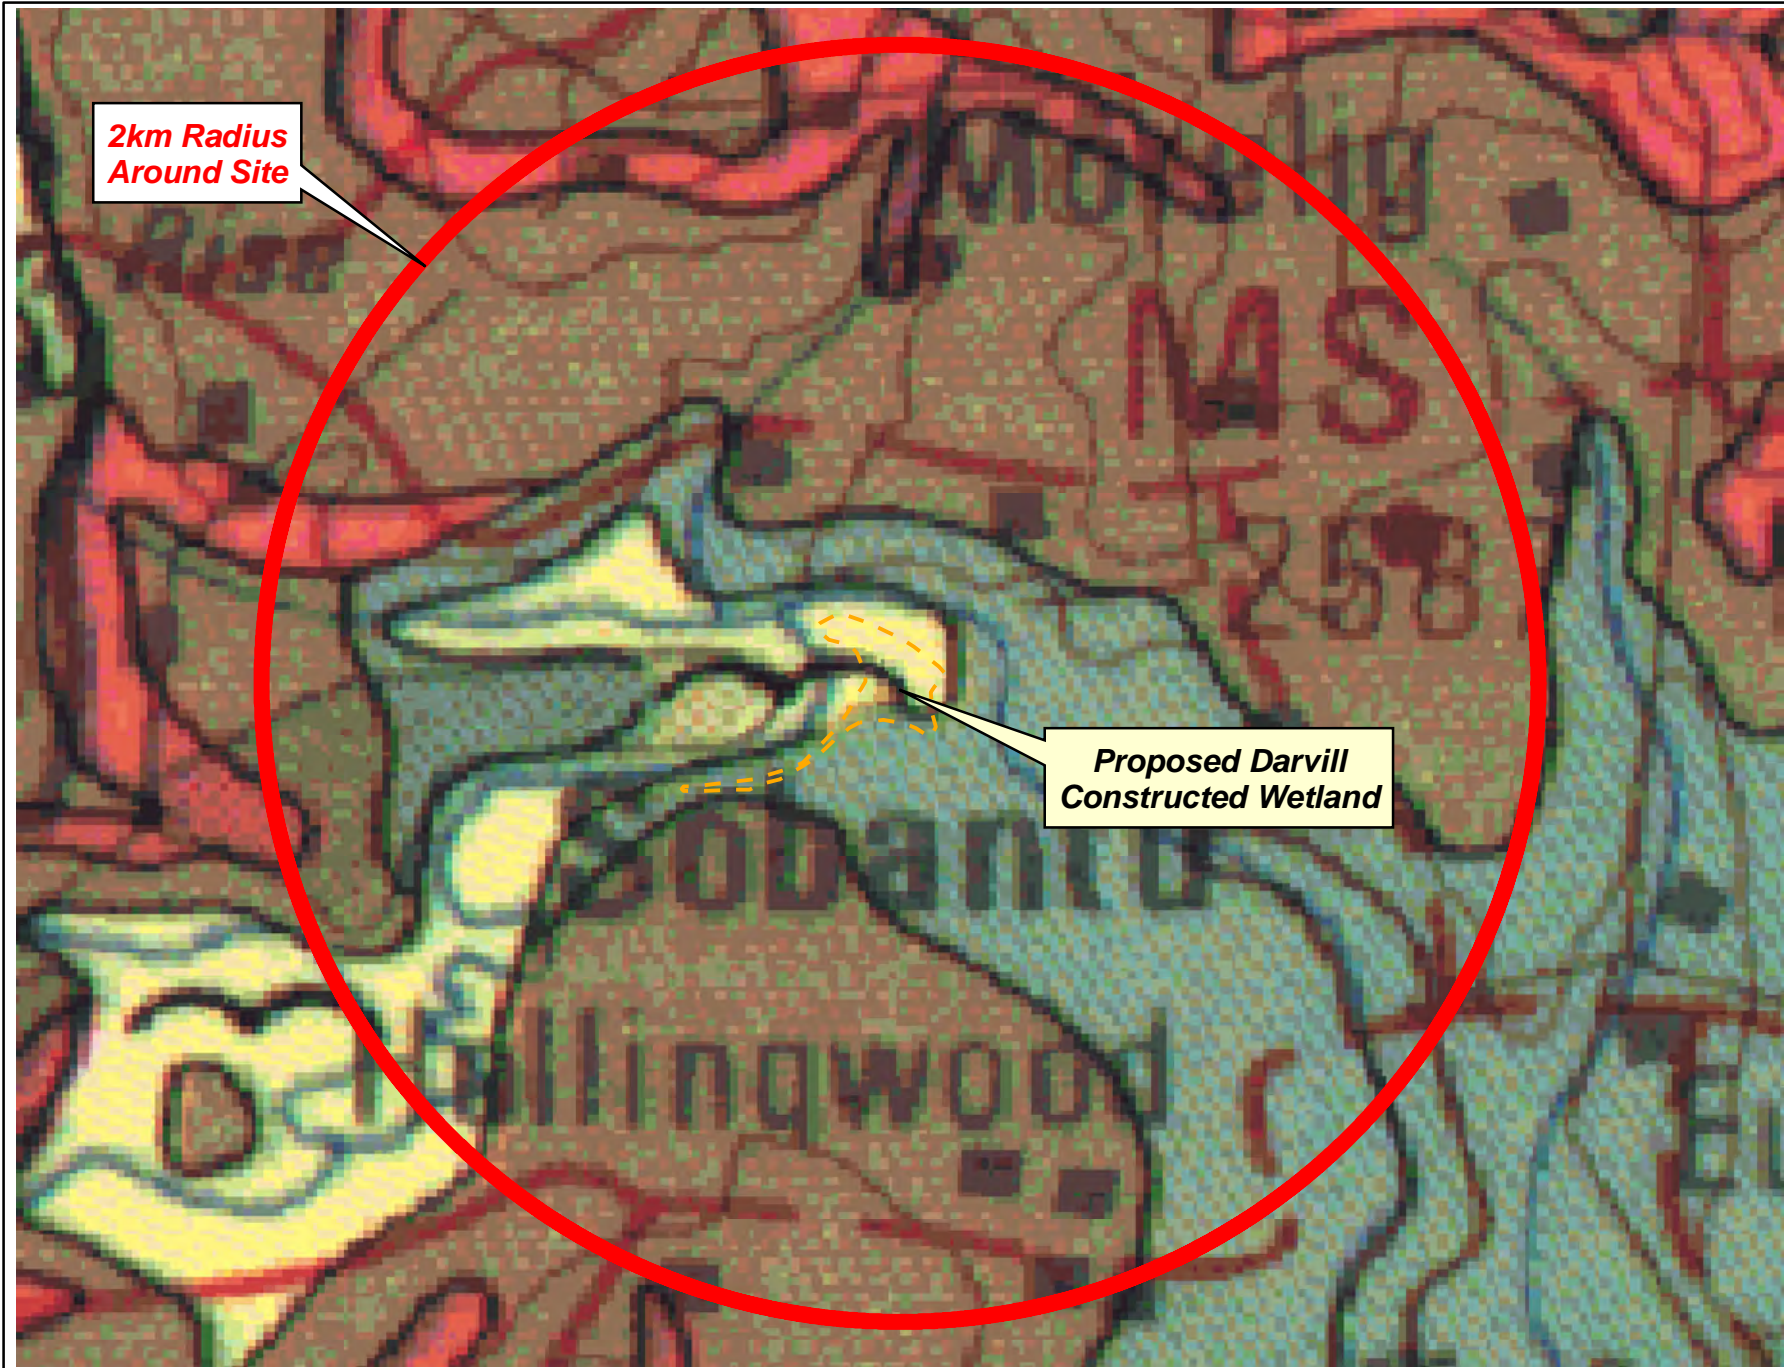
**DWG NO. 2015/232
FIGURE 2**

**2km Radius
Around Site**

**Proposed Darvill
Constructed Wetland**

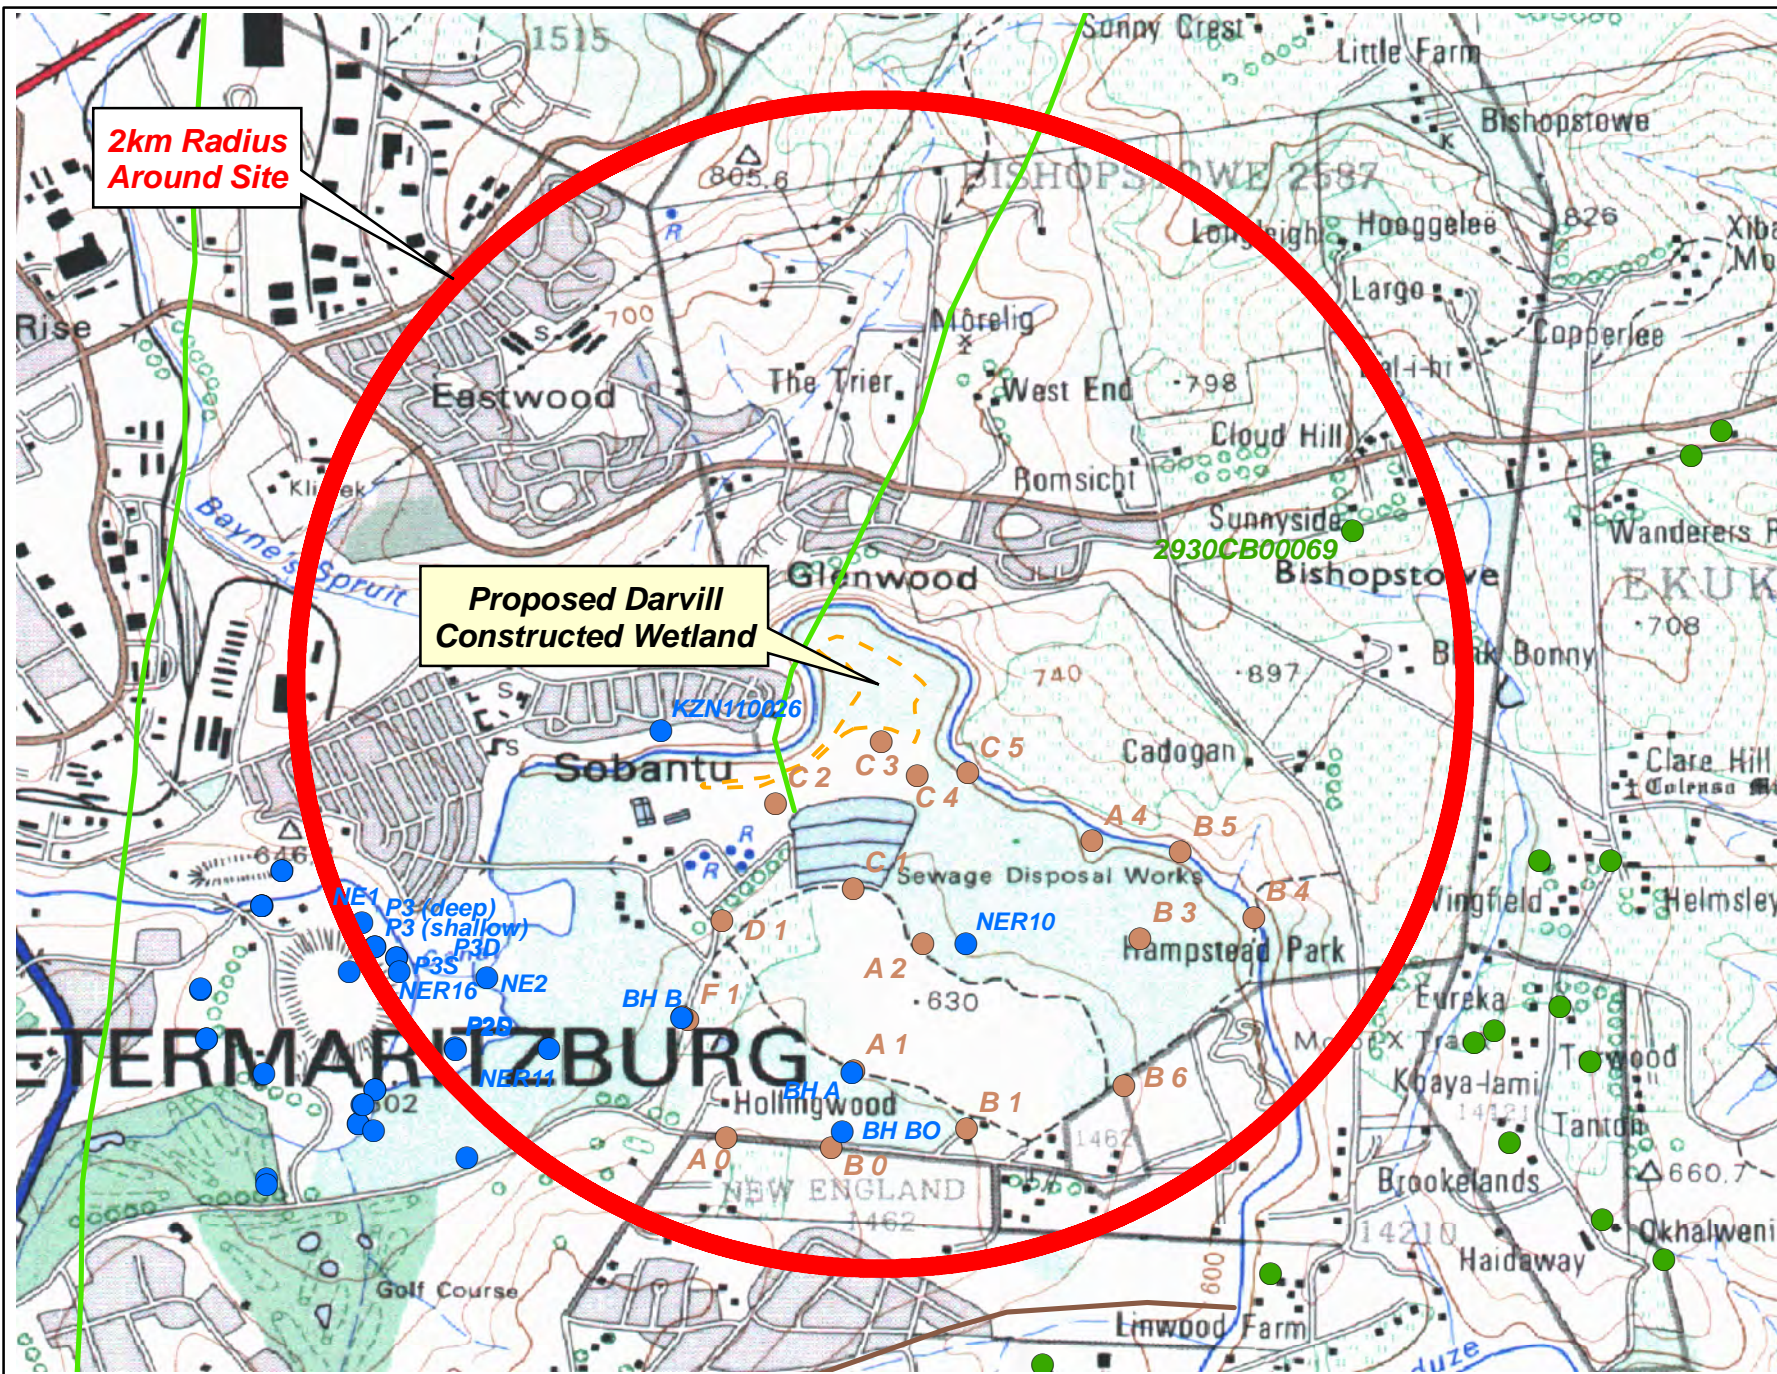
**DWG NO. 2015/232
FIGURE 3**

**2km Radius
Around Site**

**Proposed Darvill
Constructed Wetland**

The boreholes identified during the desktop and site hydrocensus are shown on the attached Area Plan – Dwg No. 2015/232 Figure 3. As can be seen, there are number of boreholes to

the south of the site on the southern side of the Msunduzi River, all of which are monitoring boreholes and the majority of which are either up-gradient or cross-gradient of the site.

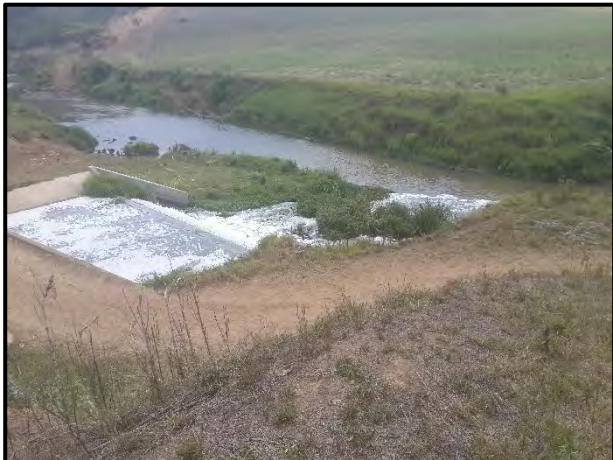
Plate 1: View of current treated effluent outflow from the Darvill Sewage Works into the Msunduzi River.

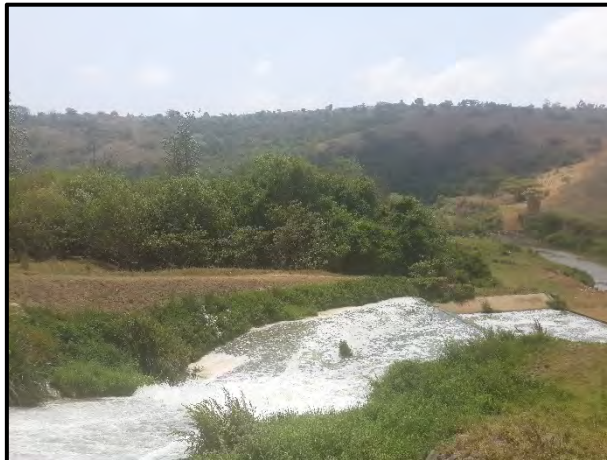
Plate 2: View of eastern area where the Darvill Constructed Wetland is to be constructed, beyond the outflow channel.

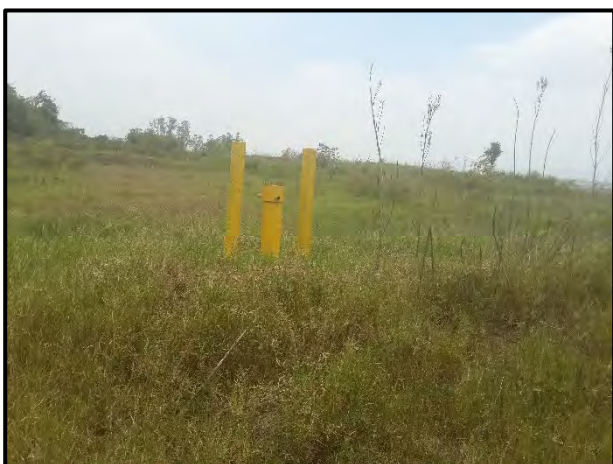
Plate 3: Existing Darvill Sewage Works monitoring borehole (C 3) just to the south of the site.

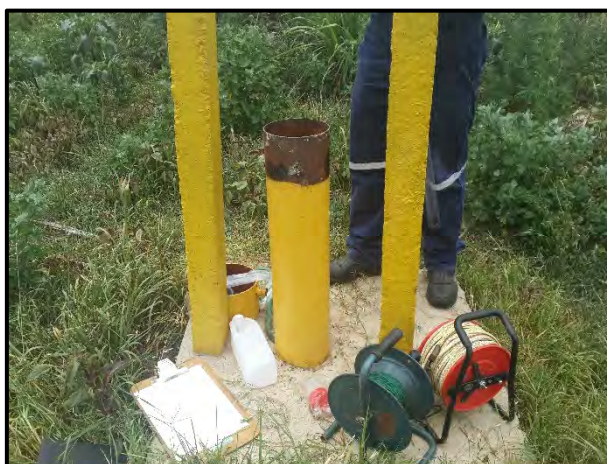
Plate 4: Monitoring and sampling of borehole B 6, located away to the south-east of the proposed site.

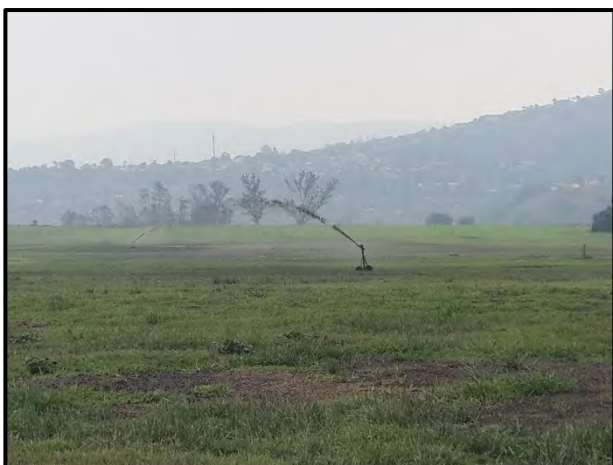
Plate 5: Treated effluent land-farming practices, to the south of the proposed site.

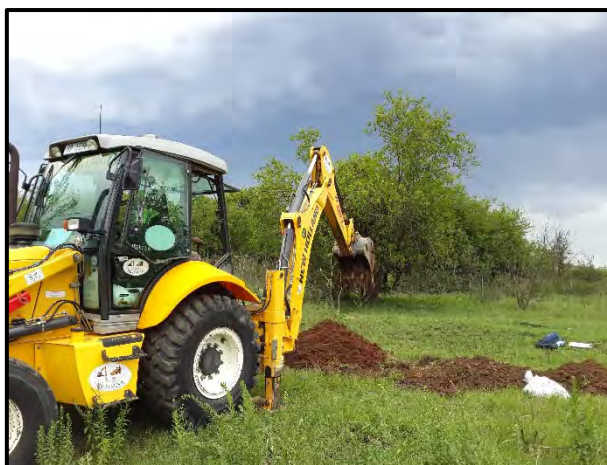
Plate 6: Excavation of trial pits during the geotechnical investigation, across the site.

During the geotechnical investigation, it was noted that the soils underlying the site in question were easily excavatable through mechanical means (TLB). Should the base of each cell not extend to competent bedrock, then the bulk earthworks involved as part of the construction of the wetland should progress relatively easily. However, should soft weathered rock (or possibly competent bedrock) be encountered during excavations, then the use of an excavator, or possibly ripping, may be required to reach the required depth. Note that said mechanical means may only be required across part of the site, where shallow depths to refusal were encountered.

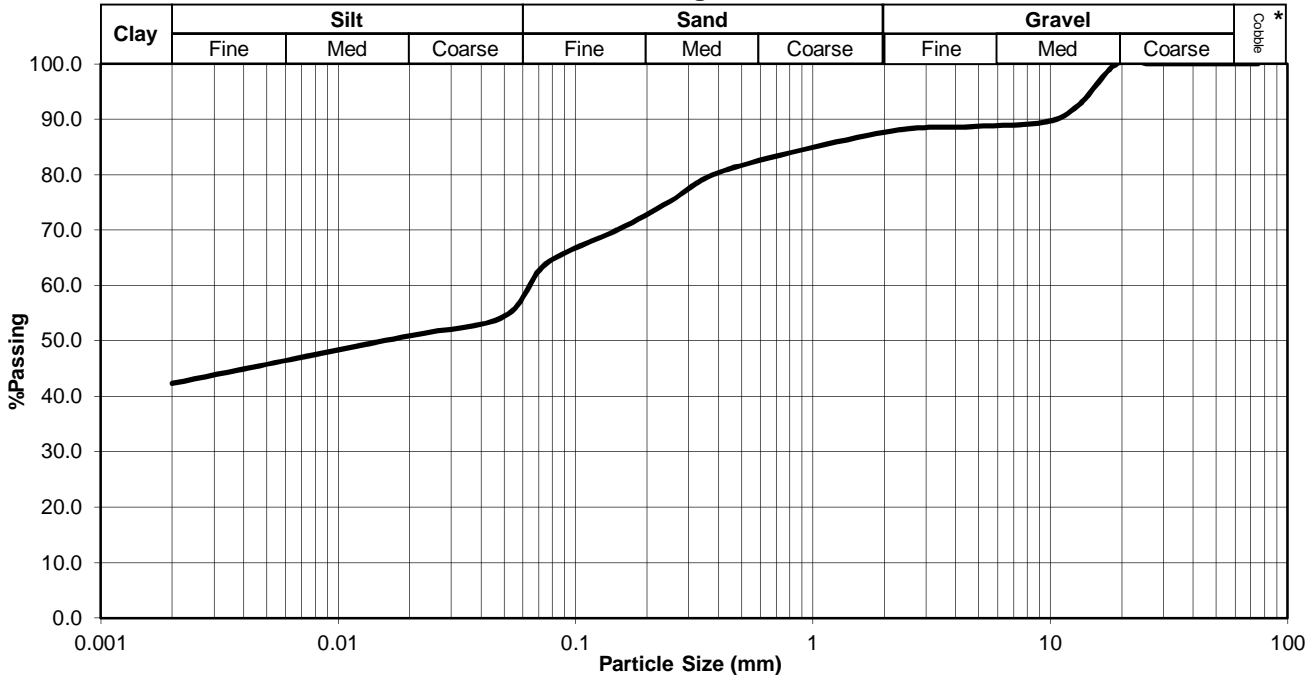
Grading Curve

CLASSIFICATION *	
Potential Expansiveness	Low
Group Index	9
AASHTO Soil Classification	A - 6
Unified Classification	CL or OL

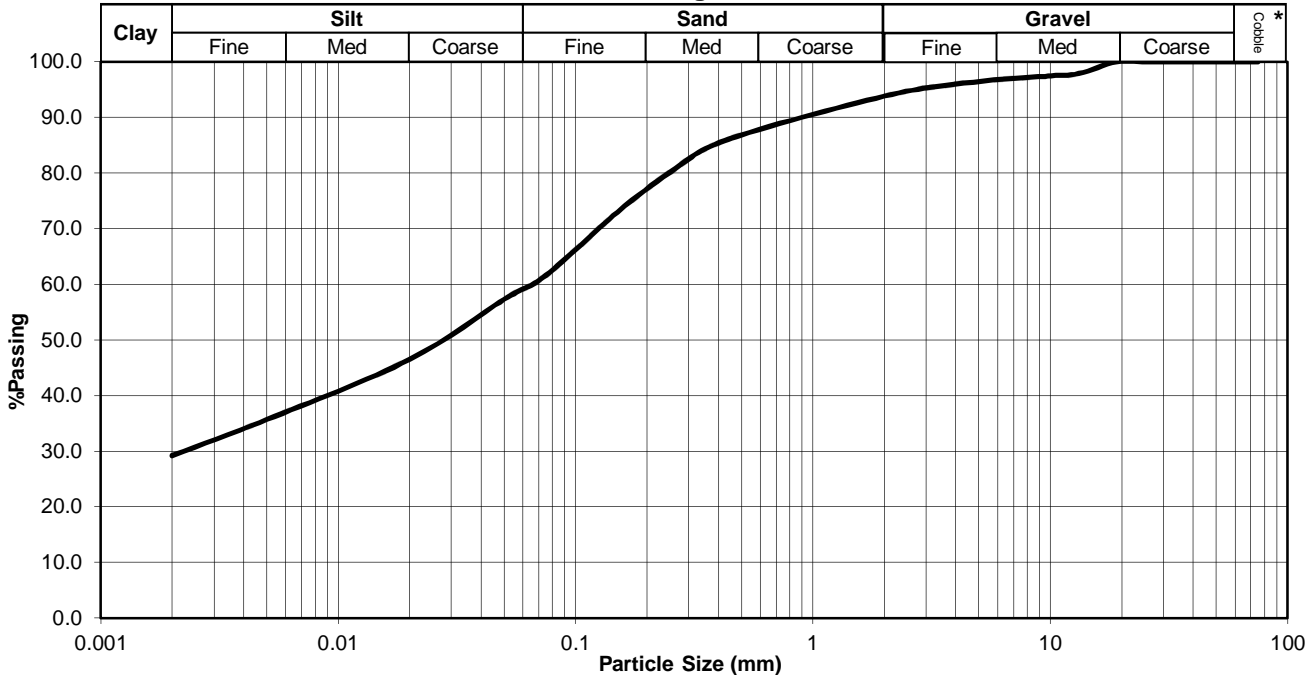
Grading Curve

CLASSIFICATION *	
Potential Expansiveness	Low
Group Index	6
AASHTO Soil Classification	A - 6
Unified Classification	CL or OL

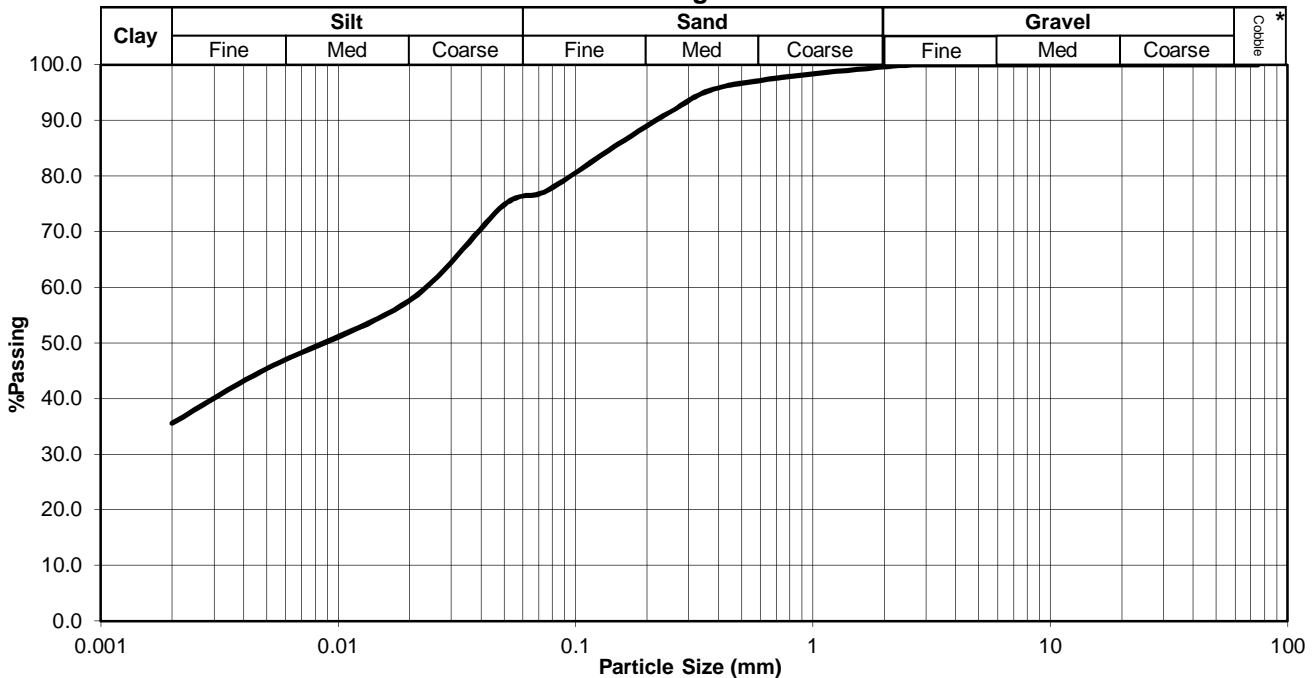
Grading Curve

CLASSIFICATION *	
Potential Expansiveness	Low
Group Index	4
AASHTO Soil Classification	A - 4
Unified Classification	CL or OL
