**Environmental Scoping Report for the Proposed
Expansion of the Pietermaritzburg Airport**

**APPENDIX 4
DRAFT WETLAND ASSESSMENT REPORT
August 2011**

**APPENDIX 3:
DRAFT WETLAND ASSESSMENT REPORT**

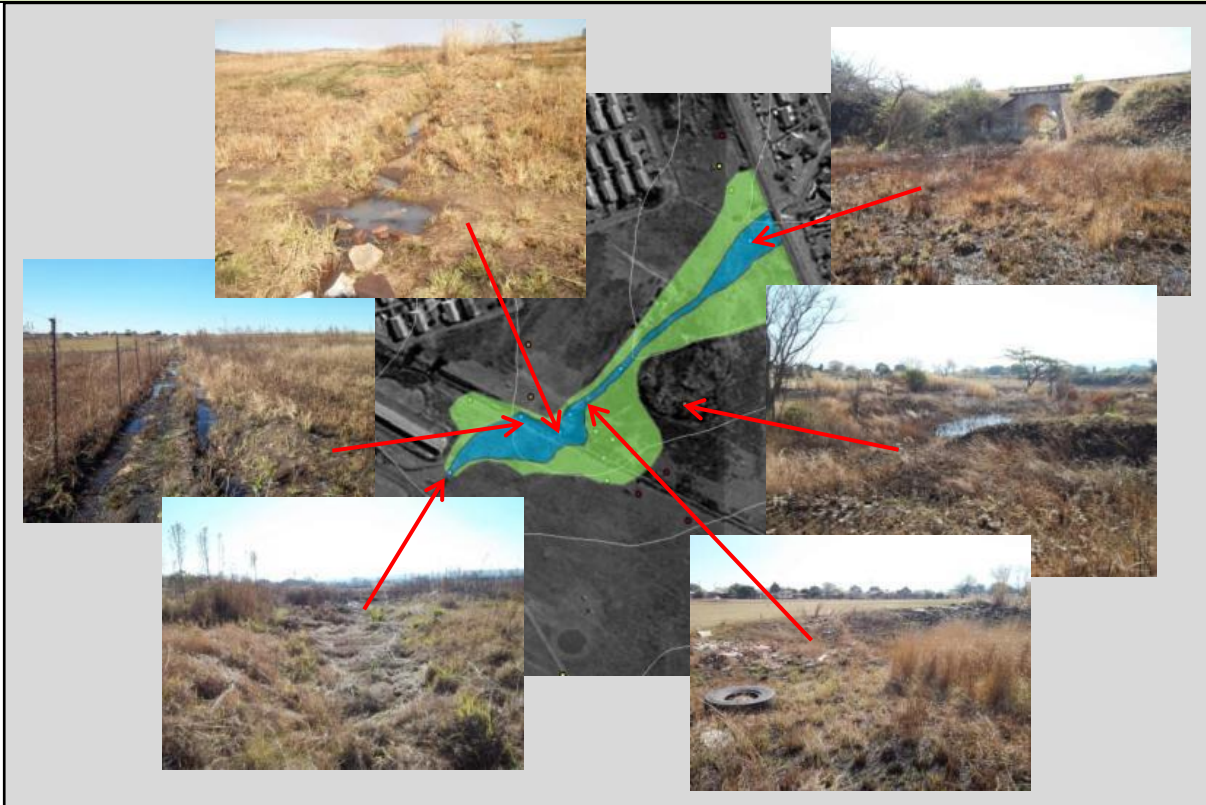
Wetland 1	<div style="background-color: #d9ead3; padding: 5px; text-align: center;">W1 – Disturbed Valleyhead / Hillslope Seep linked to a Channel</div> <div style="text-align: center; margin: 10px 0;">

</div> <p>Wetland 1 is a disturbed valleyhead seepage wetland, which has been extensively transformed through anthropogenic activities, including but not limited to:</p> <ul style="list-style-type: none"> • The construction of the existing Oribi Airport infrastructure and associated infrastructure; • Oribi village and sports fields at the village (portion of the wetland has been cleared for a soccer field); • Fencing; • Construction of channels / drains within the wetland to drain stormwater runoff from the airport (this includes water from the
------------------	--

- The on-going cutting and burning of vegetation in the vicinity of the airport for safety purposes;
- The dumping of rubble and litter within the wetland;
- Alien vegetation; and
- The construction of a railway bridge, which has resulted in a 'pinch' in the wetland. It should be noted that downstream of this railway bridge is an urban area where the wetland has been largely destroyed and in some places replaced with a canal.

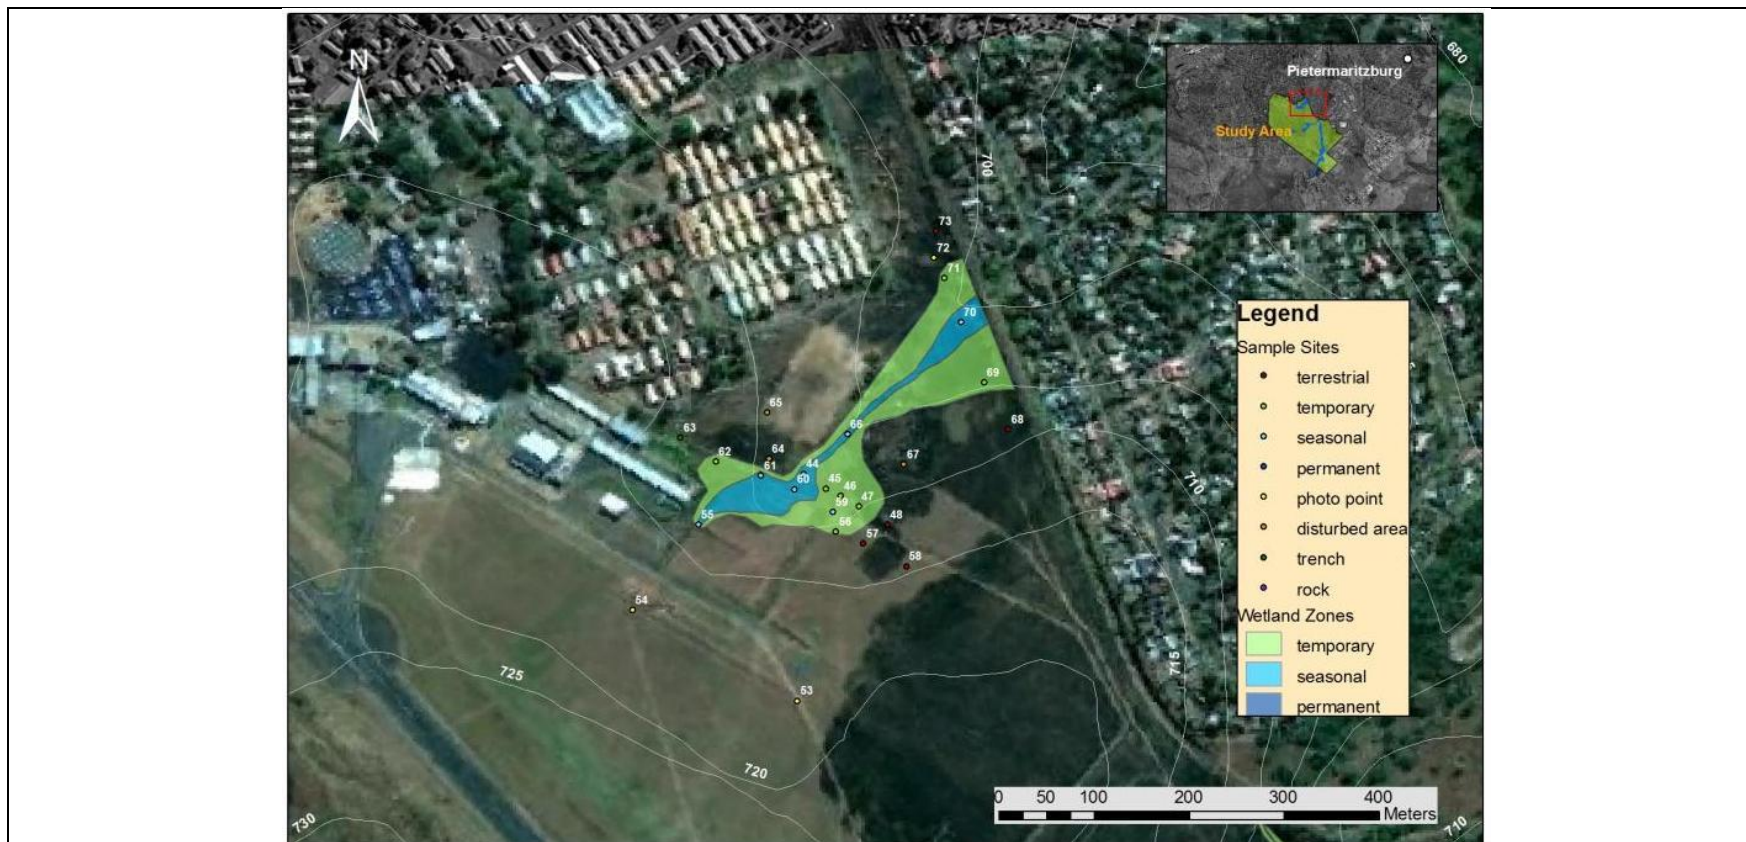
Wetland Delineation

Refer to the *Appendix* for a list of characteristics for each of the sample sites identified in the delineation map. Disturbances to the soil profile and vegetation layer restricted the accuracy of the delineation. A brief site visit will need to be conducted during optimal conditions (i.e. spring / summer) to verify the findings from this initial delineation.

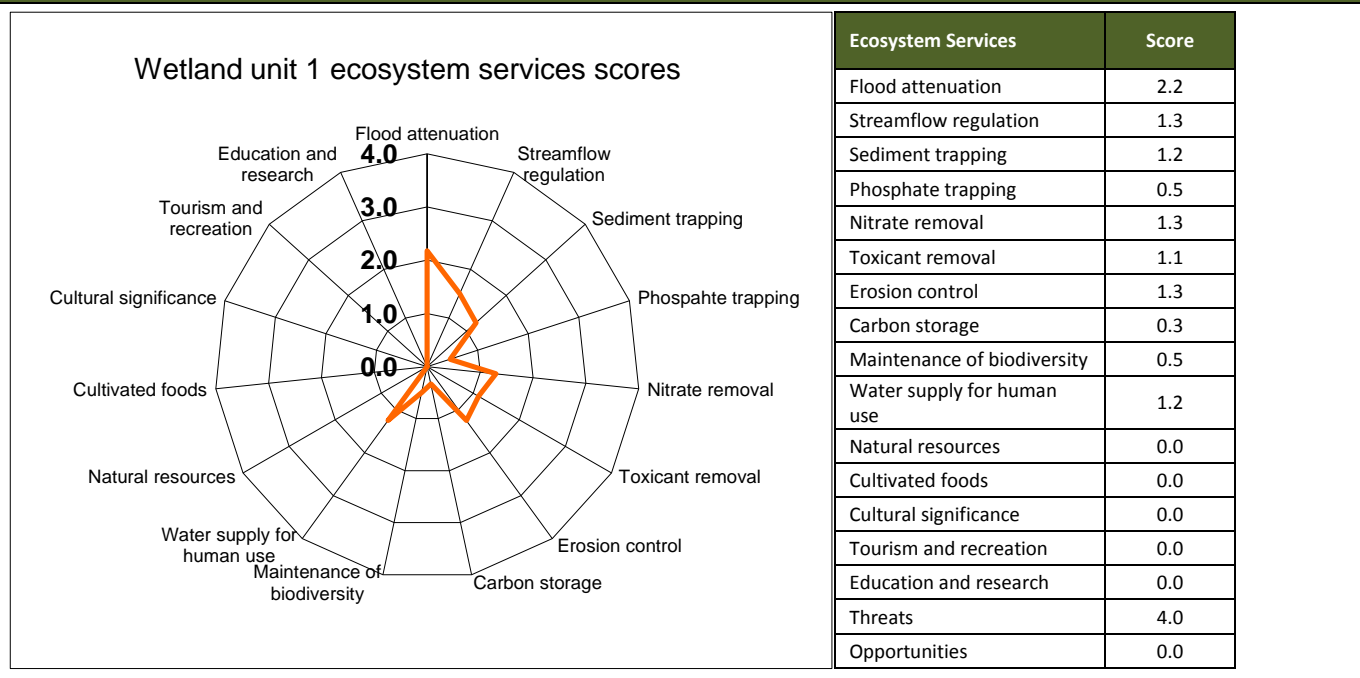
Ecosystem Services

Due to extensive disturbances to this wetland ecosystem services in general scored poorly. Hillslope / valleyhead seeps generally slow the movement of water through the catchment, which has a number of benefits, i.e. such as enhancing the quality of water. However, this wetland has been artificially canalized to accommodate stormwater runoff from the airport precinct. In addition the adjacent

urban area has resulted in the loss of a significant portion of the wetland, i.e. through the clearing of soil / levelling of an area for a soccer field, etc. Flood attenuation scored the highest, which is indicative of the natural functioning of a seepage wetland (particularly early in the rainy season). Limited streamflow regulation, sediment trapping, enhancing of water quality and erosion control is still provided by the small portions of remaining seepage areas (i.e. portions not canalized). Water supply for human use only scored a 'relatively' high score due to its association with streamflow regulation.

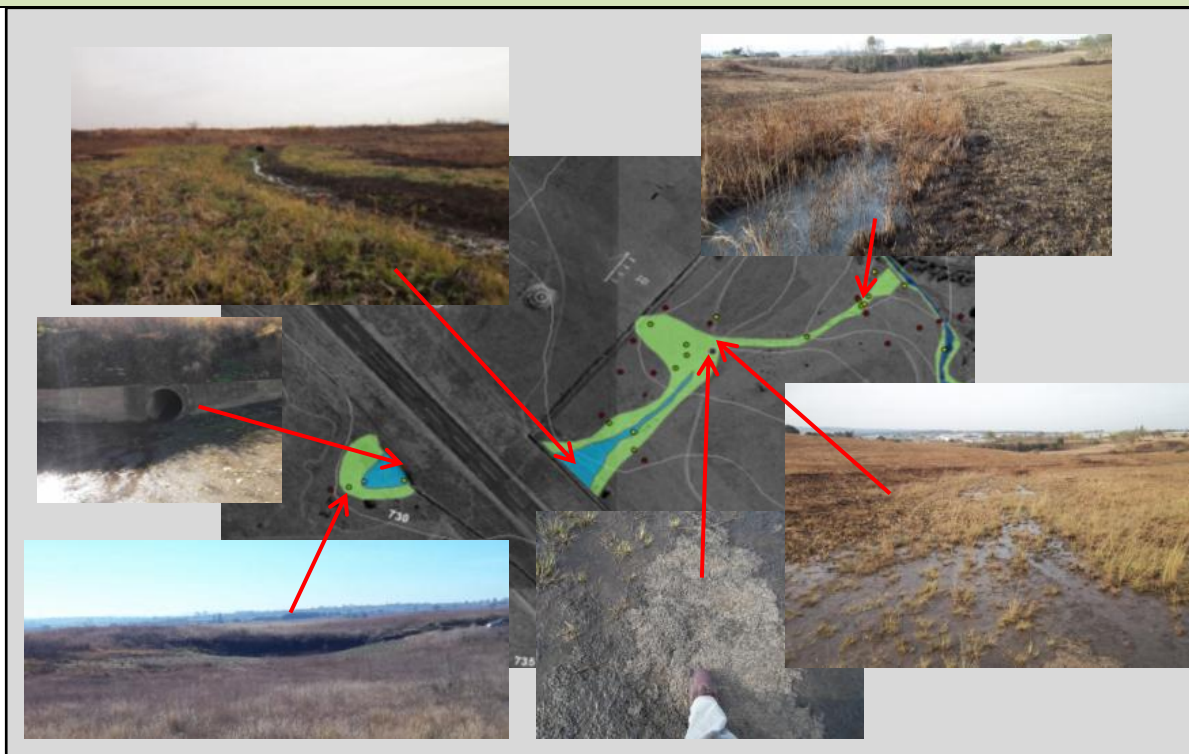
W2 – Disturbed Valleyhead / Hillslope Seep linked to a Channel

Wetland 2 is a disturbed valleyhead / hillslope seepage wetland, which has been transformed through anthropogenic activities, including but not limited to:

- The construction of the Oribi airport runway directly through the wetland upper portion of the wetland;
- The canalization of the wetland downstream of the culverts under the runway;
- The removal of wetland soils within portions of the wetland (i.e. particularly upstream of the runway); and

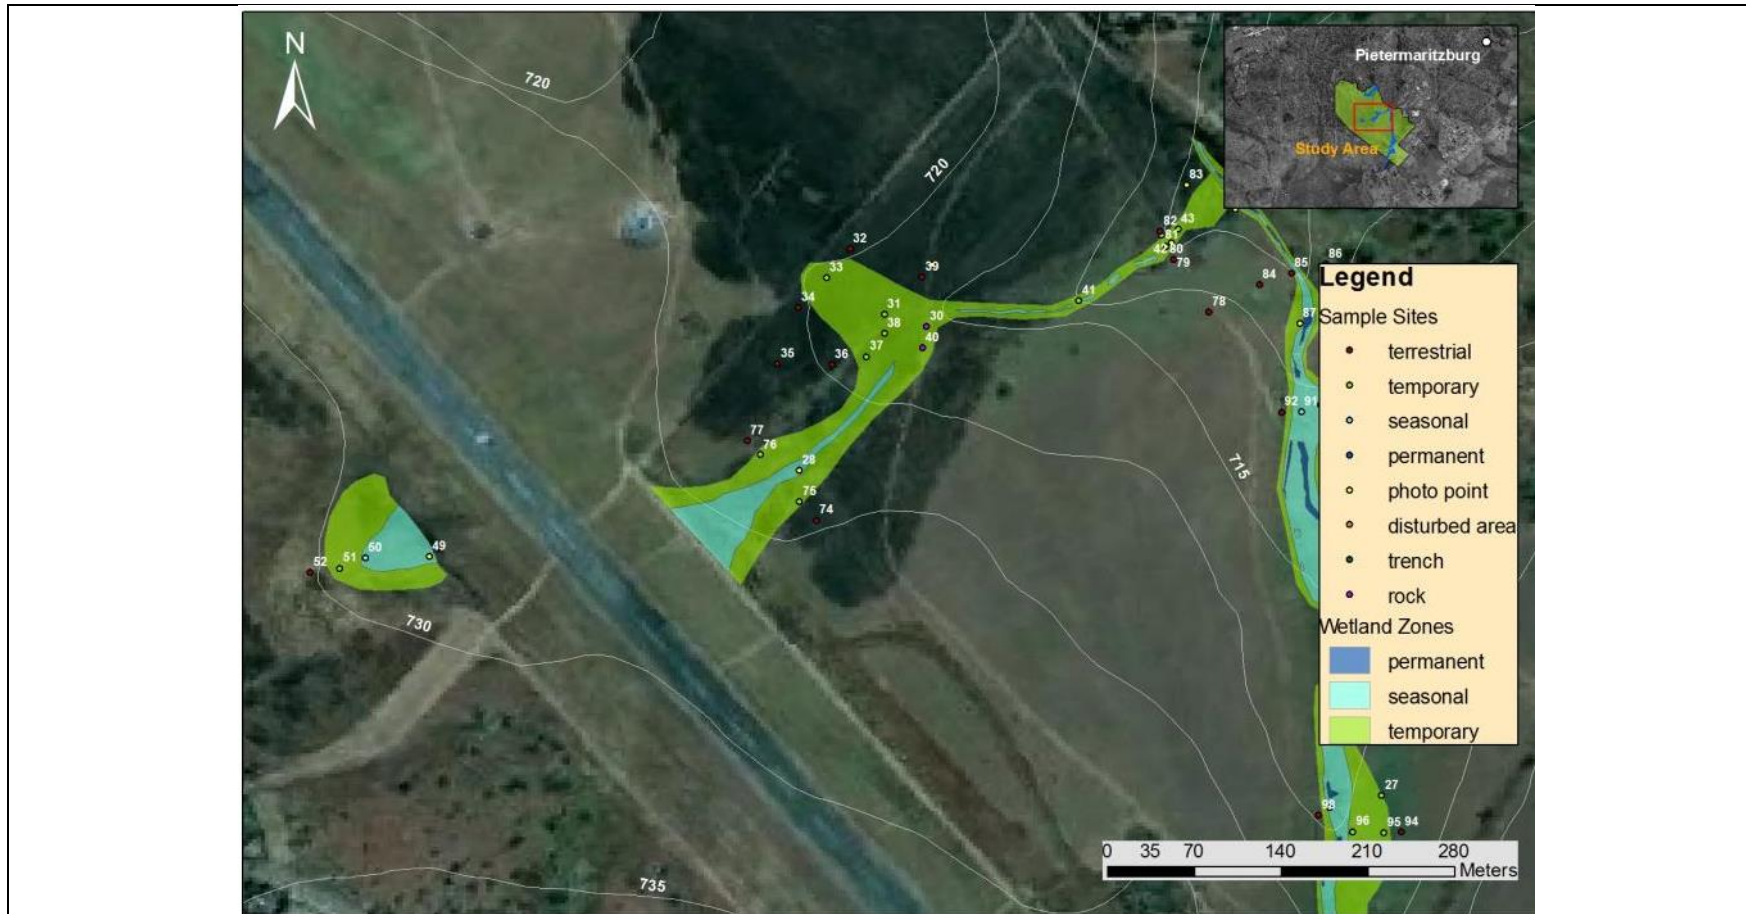
Wetland Delineation

Refer to the *Appendix* for a list of characteristics for each of the sample sites identified in the delineation map. Disturbances to the vegetation (i.e. recently burnt) restricted the accuracy of the delineation. A brief site visit will need to be conducted during optimal conditions (i.e. spring / summer) to verify the findings from this initial delineation.

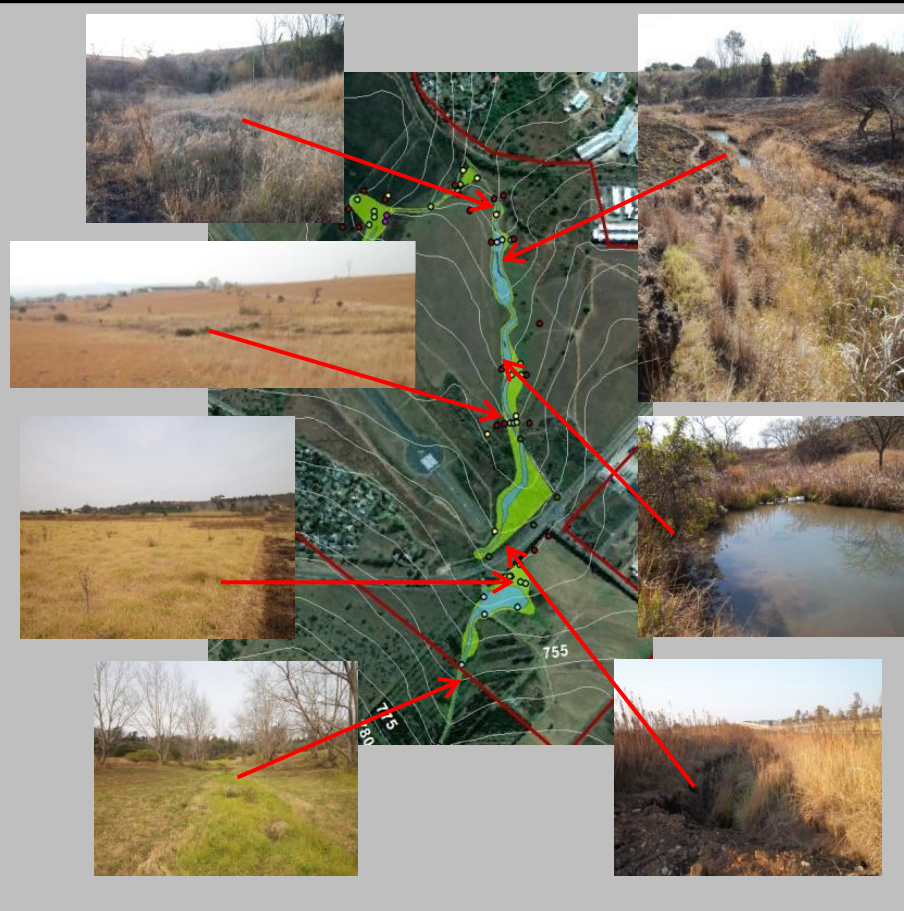
W3 – Valley bottom with a channel

Wetland 3 is a disturbed channelled valley bottom wetland, which has been largely transformed through anthropogenic activities, including but not limited to:

- Farming activities in the catchment and the upper reaches of the channel. These include the converting of wetland areas to pastures and clearing for the cultivation of various crops;
- A tar road (Gladys Manzi), which cuts through the top portion of the wetland;
- A light industrial area within the catchment. Stormwater runs directly into the wetland;
- Deep trenches have been dug for water pipelines adjacent to the tar road. These trenches run directly through the top portion of the wetland and also along it;
- The dumping of rubble and litter within the wetland, primarily downstream of the tar road and the trenches;
- Alien vegetation; and
- The construction of a railway bridge, which has resulted in a ‘pinch’ in the wetland, i.e. the toe of the wetland.

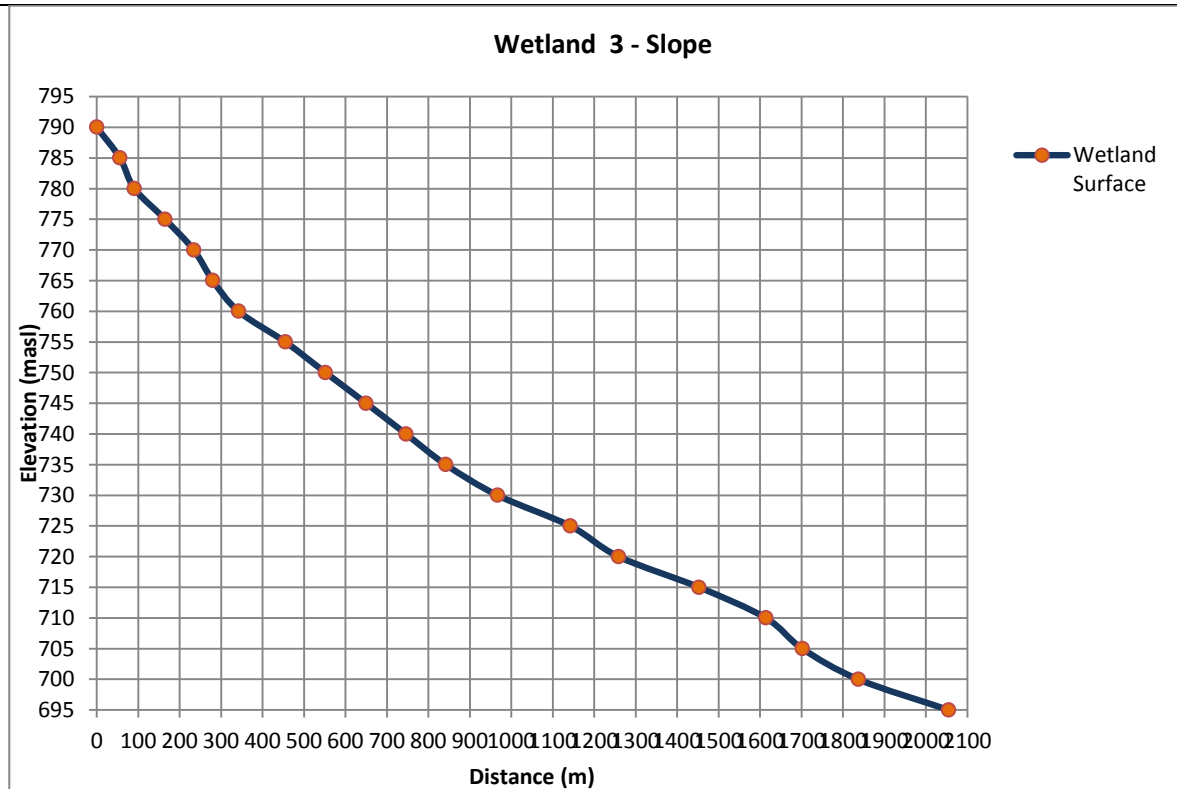
The slope of the wetland = 4.9%. The reduction in the slope at an elevation of approximately 710m is indicative of the underlying

dolerite.
