Environmental Scoping Report for the Proposed Expansion of the Pietermaritzburg Airport

APPENDIX 4 DRAFT WETLAND ASSESSMENT REPORT August 2011

# **DRAFT WETLAND ASSESSMENT REPORT**

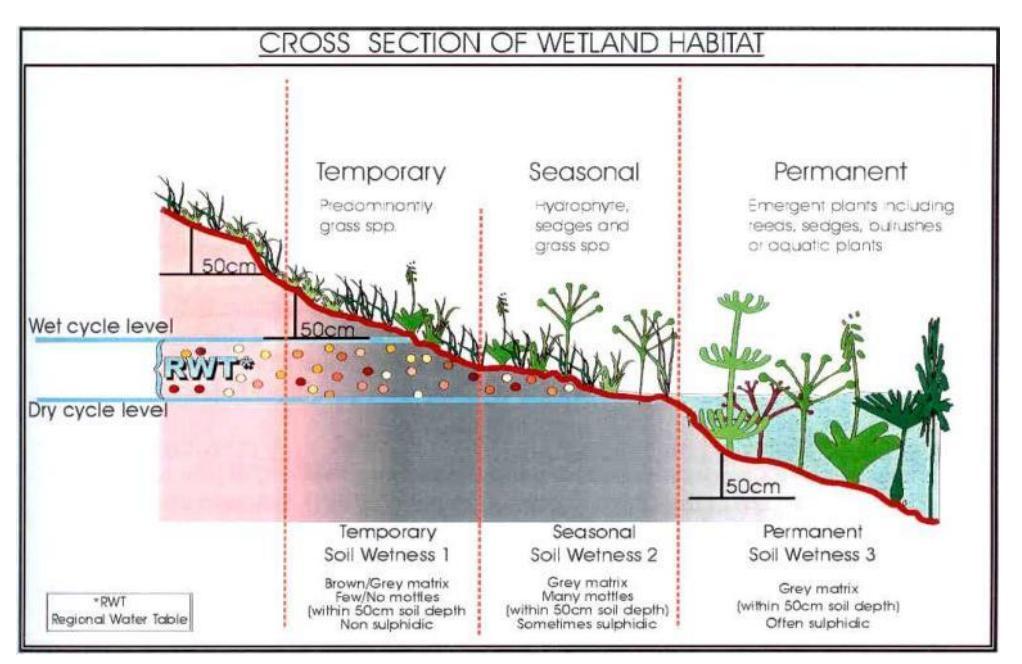
Figure 2: Cross section through a wetland, indicating how the soil wetness and vegetation indicators change as one moves along a gradient of decreasing wetness, from the middle to the edge of the wetland (Kotze, 1996; DWAF, 2005)

Furthermore, wetlands must have one or more of the following attributes (Figure 2):

- Wetland (hydromorphic) soils that display characteristics resulting from prolonged saturation;
- The presence, at least occasionally, of water loving plants (hydrophytes); and
- A high water table that results in saturation at or near the surface, leading to anaerobic conditions developing in the top 50cm of the soil (DWAF, 2005).

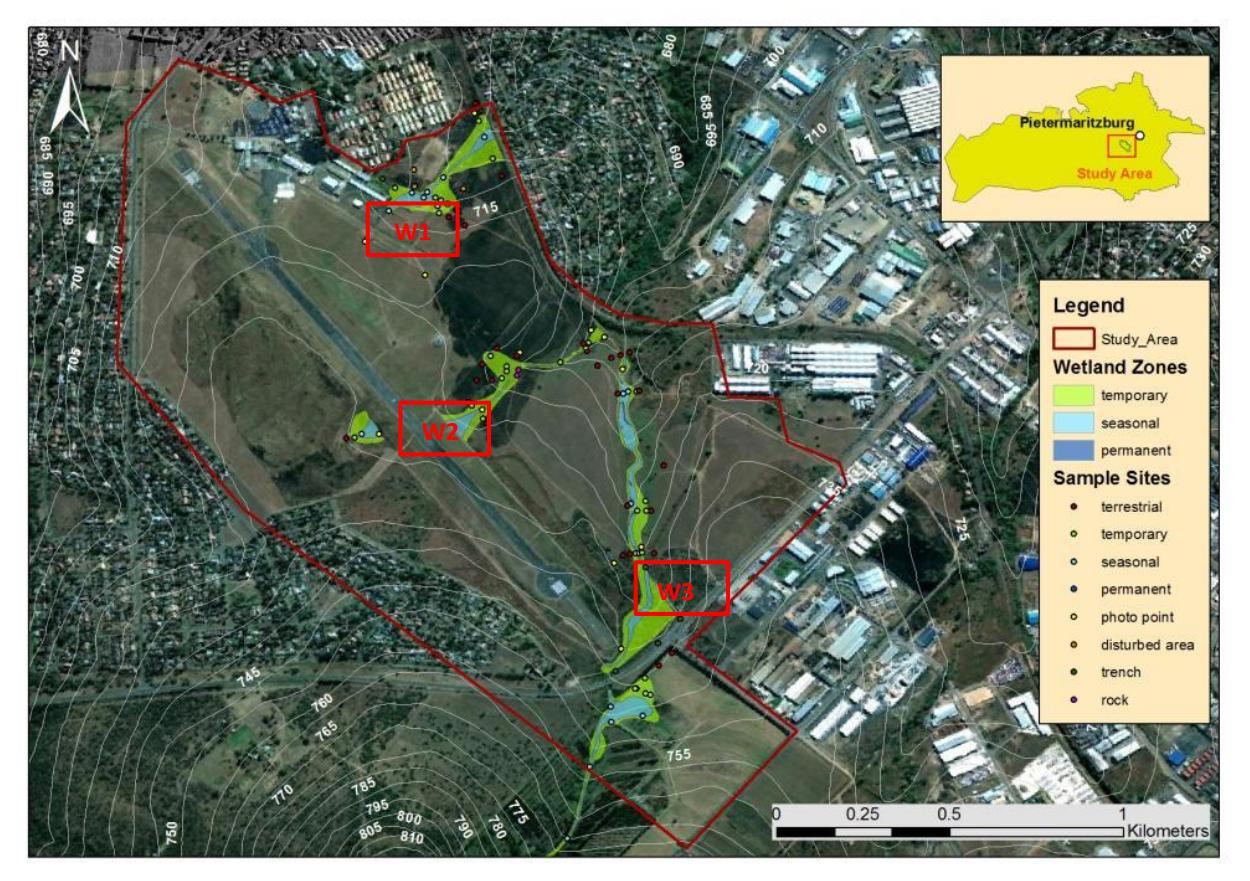
Figure 3: Wetland within the study site

There are three primary wetlands within the study (Figure 3), which include:

- W1 Disturbed Hillslope seep / Valleyhead seep linked to a stream channel;
- W2 Disturbed Hillslope seep / Valleyhead seep linked to a stream channel; and
- W3 Disturbed Valley bottom with a channel.

All of these wetlands have extensive anthropogenic impacts, which have diminished their ecological state (some more than others but in general all three are degraded). These disturbances, which will be discussed for the individual wetlands, have played a role in shaping the wetlands that remain today. However, geological features are also playing a significant role in the functioning and shaping of the wetlands (primarily W2 and W3). Figure 4 below highlights the board underlying geological features in the area.

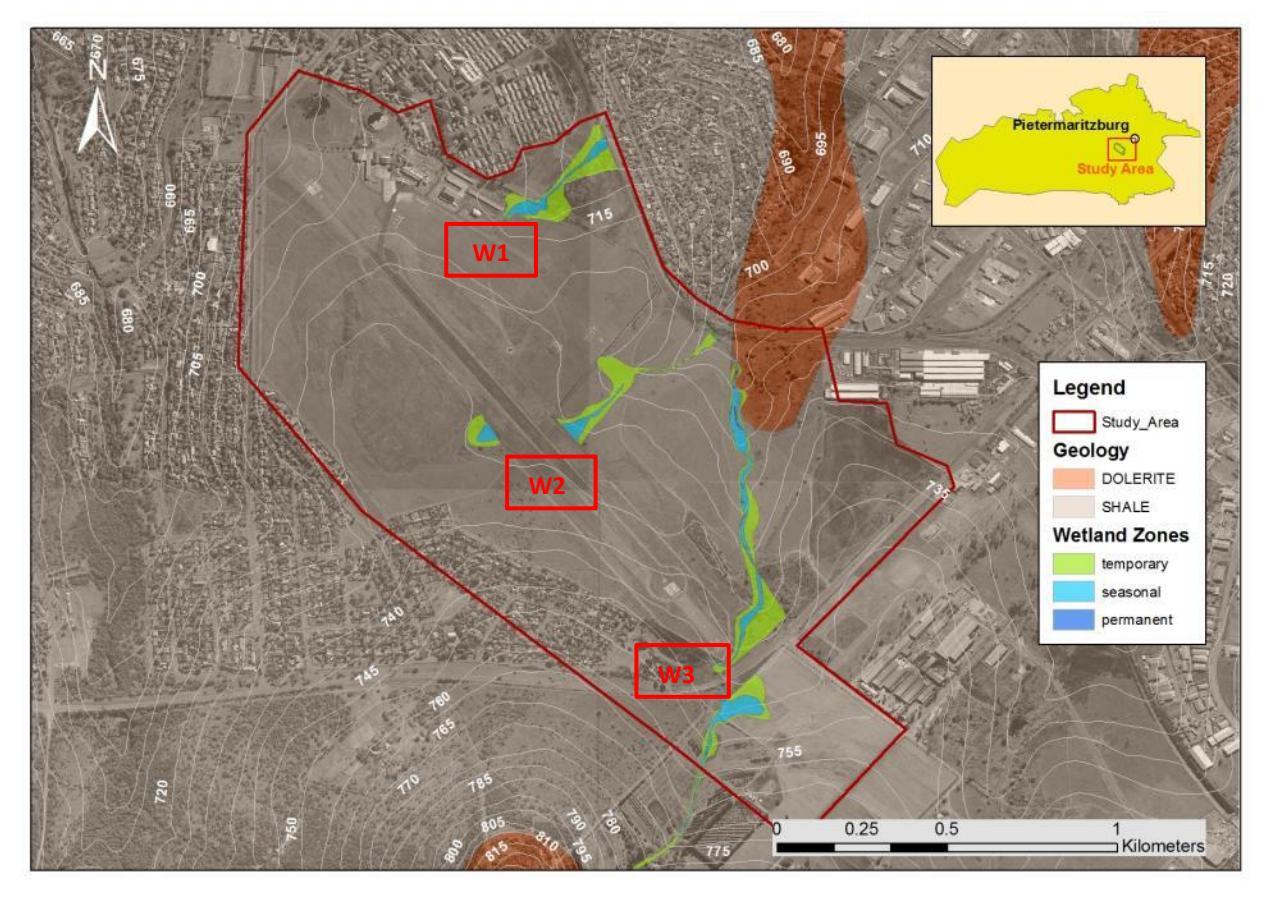
Figure 4: Geology Map

The toe of wetlands W2 and W3 are superimposed on dolerite, which in comparison to the largely shale surroundings is a much harder material and therefore more resistant to erosion. As a result the available energy is used to erode the channel systems further up the wetlands, which is likely has been the cause for the formation of gullies on both of these systems. This geological feature is enhanced by the presence of an old raised railway line directly downstream of the toe of these two wetlands, which has resulted in a 'pinch / narrowing' in the channelled system.

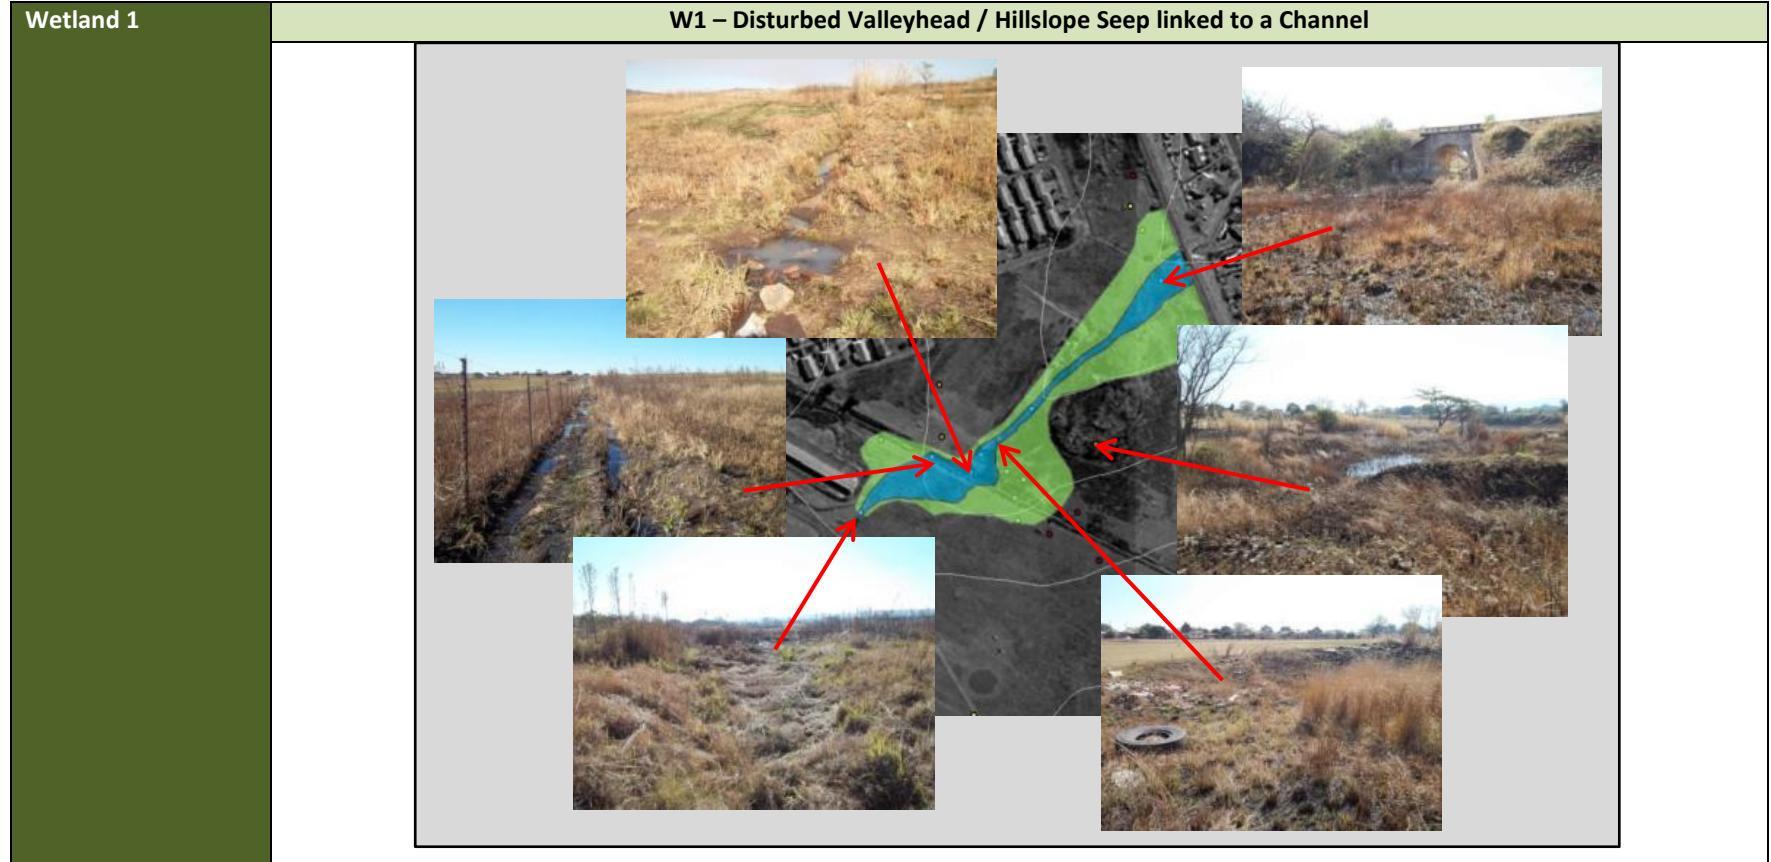
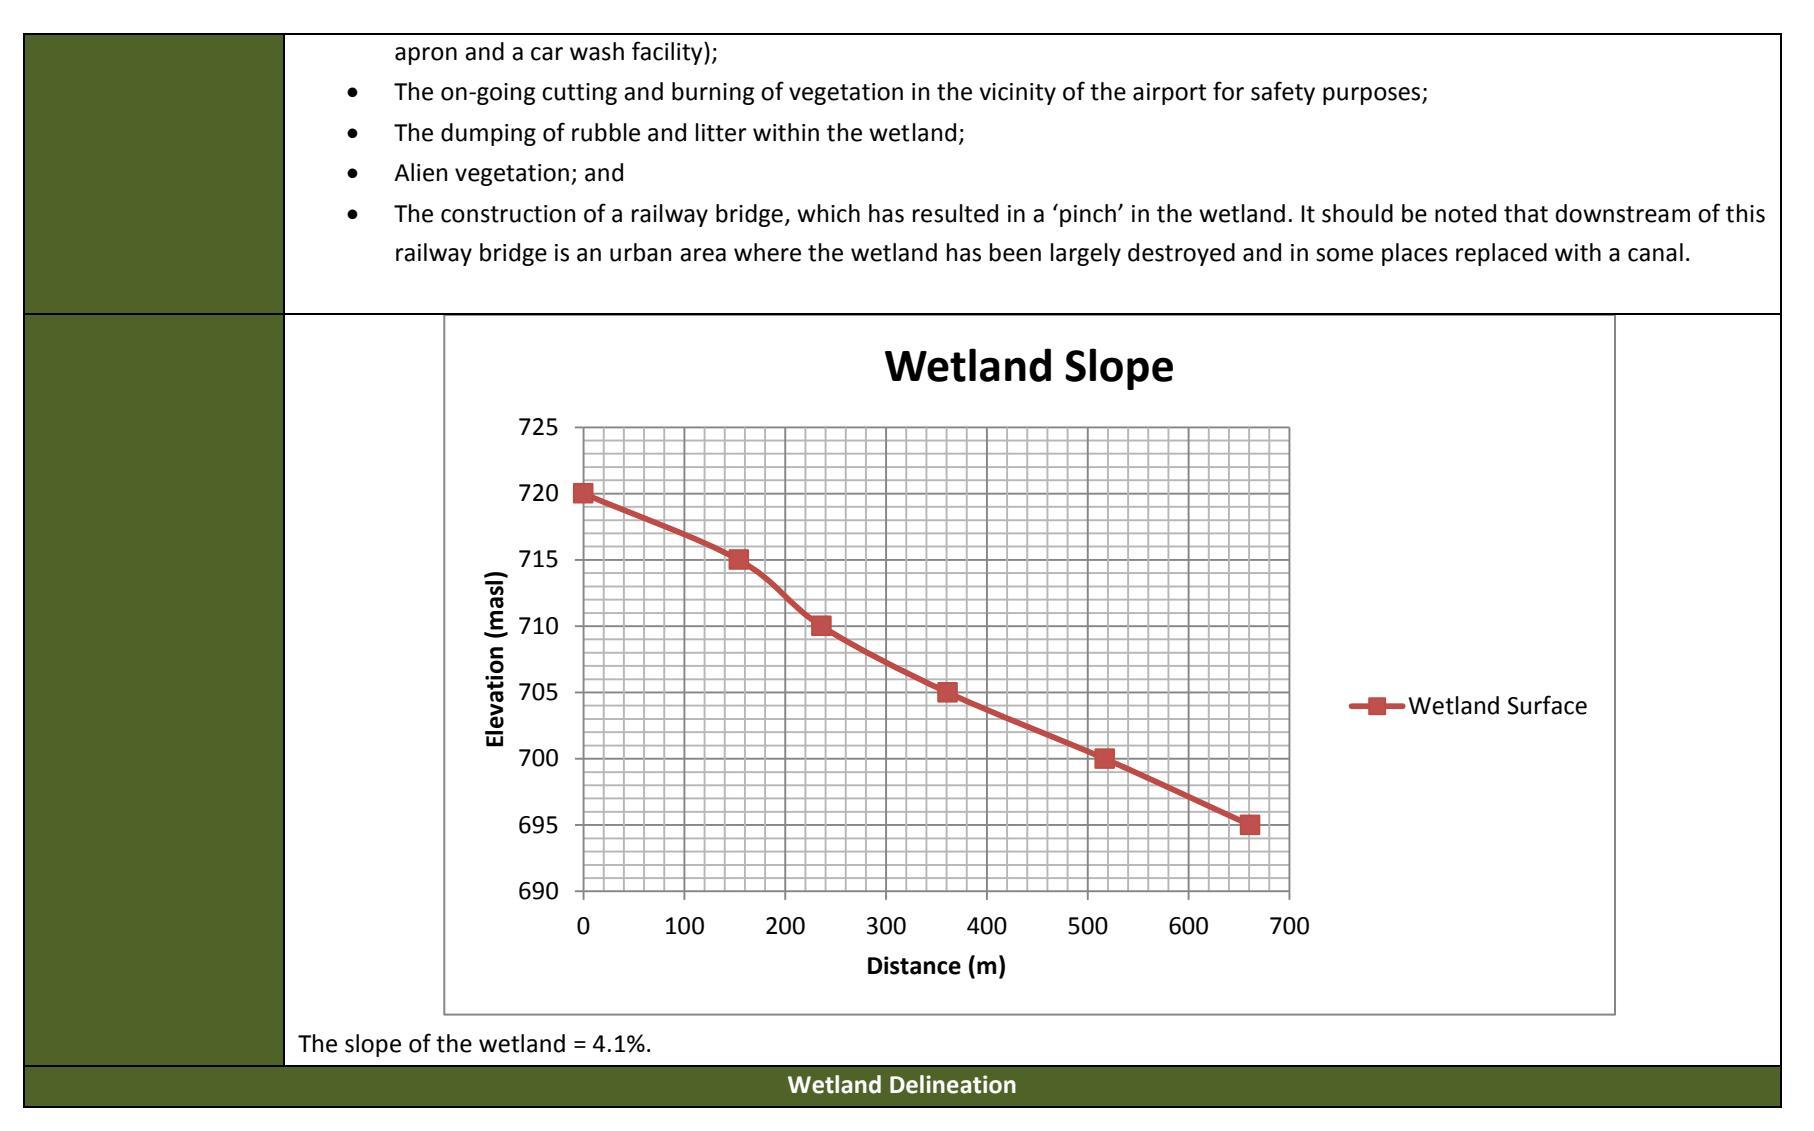
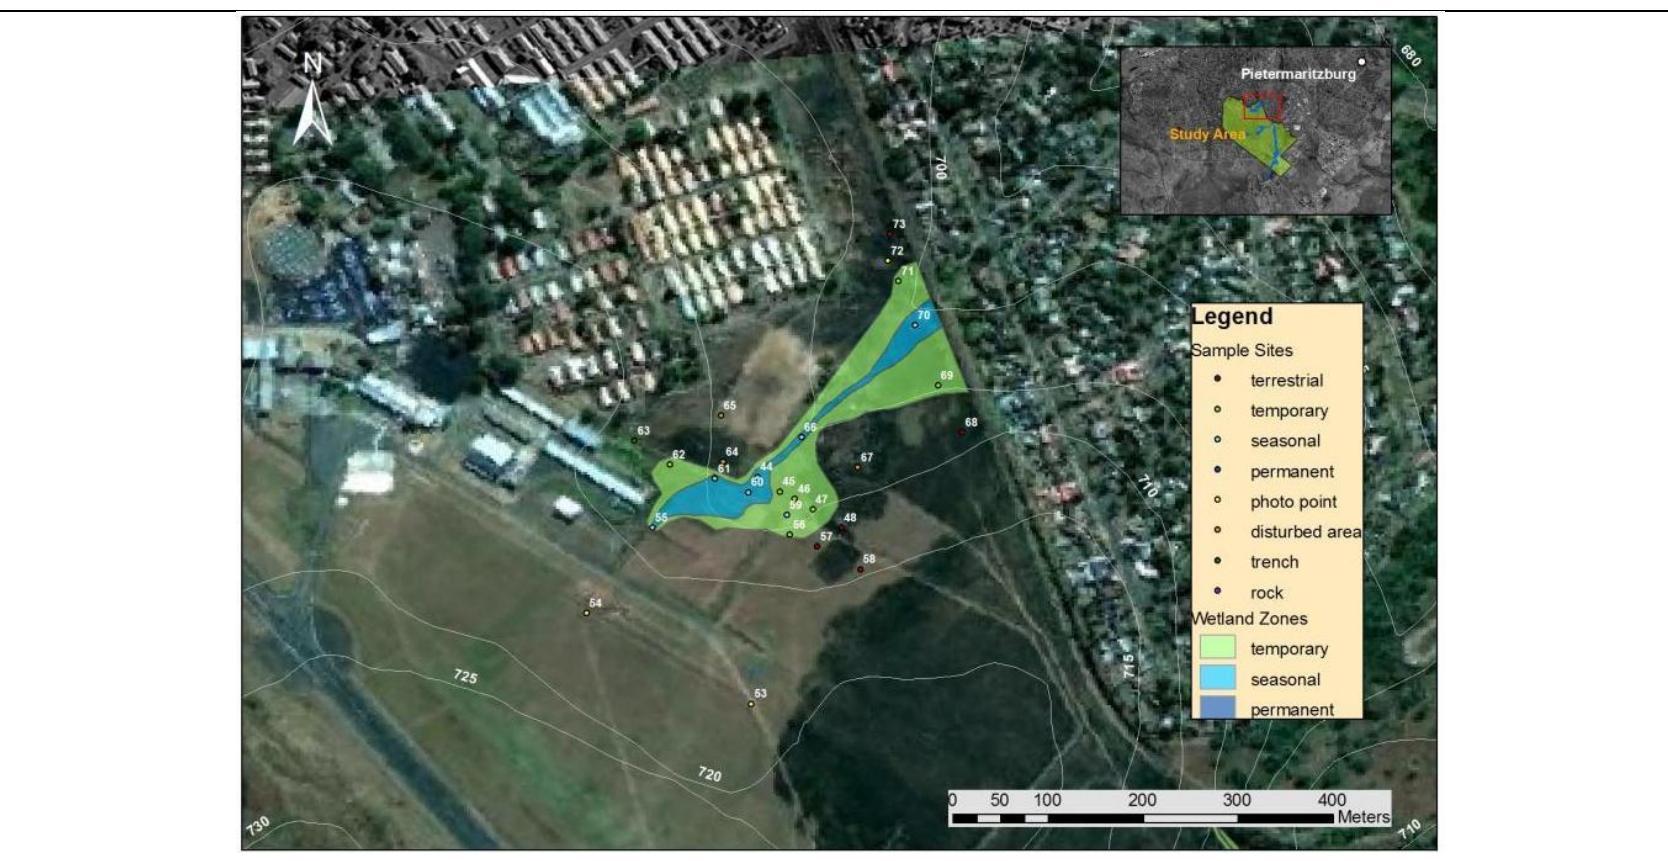
Wetland 1 is a disturbed valleyhead seepage wetland, which has been extensively transformed through anthropogenic activities, including but not limited to:

- The construction of the existing Oribi Airport infrastructure and associated infrastructure;
- Oribi village and sports fields at the village (portion of the wetland has been cleared for a soccer field);
- Fencing;
- Construction of channels / drains within the wetland to drain stormwater runoff from the airport (this includes water from the

Refer to the *Appendix* for a list of characteristics for each of the sample sites identified in the delineation map. Disturbances to the soil profile and vegetation layer restricted the accuracy of the delineation. A brief site visit will need to be conducted during optimal conditions (i.e. spring / summer) to verify the findings from this initial delineation.

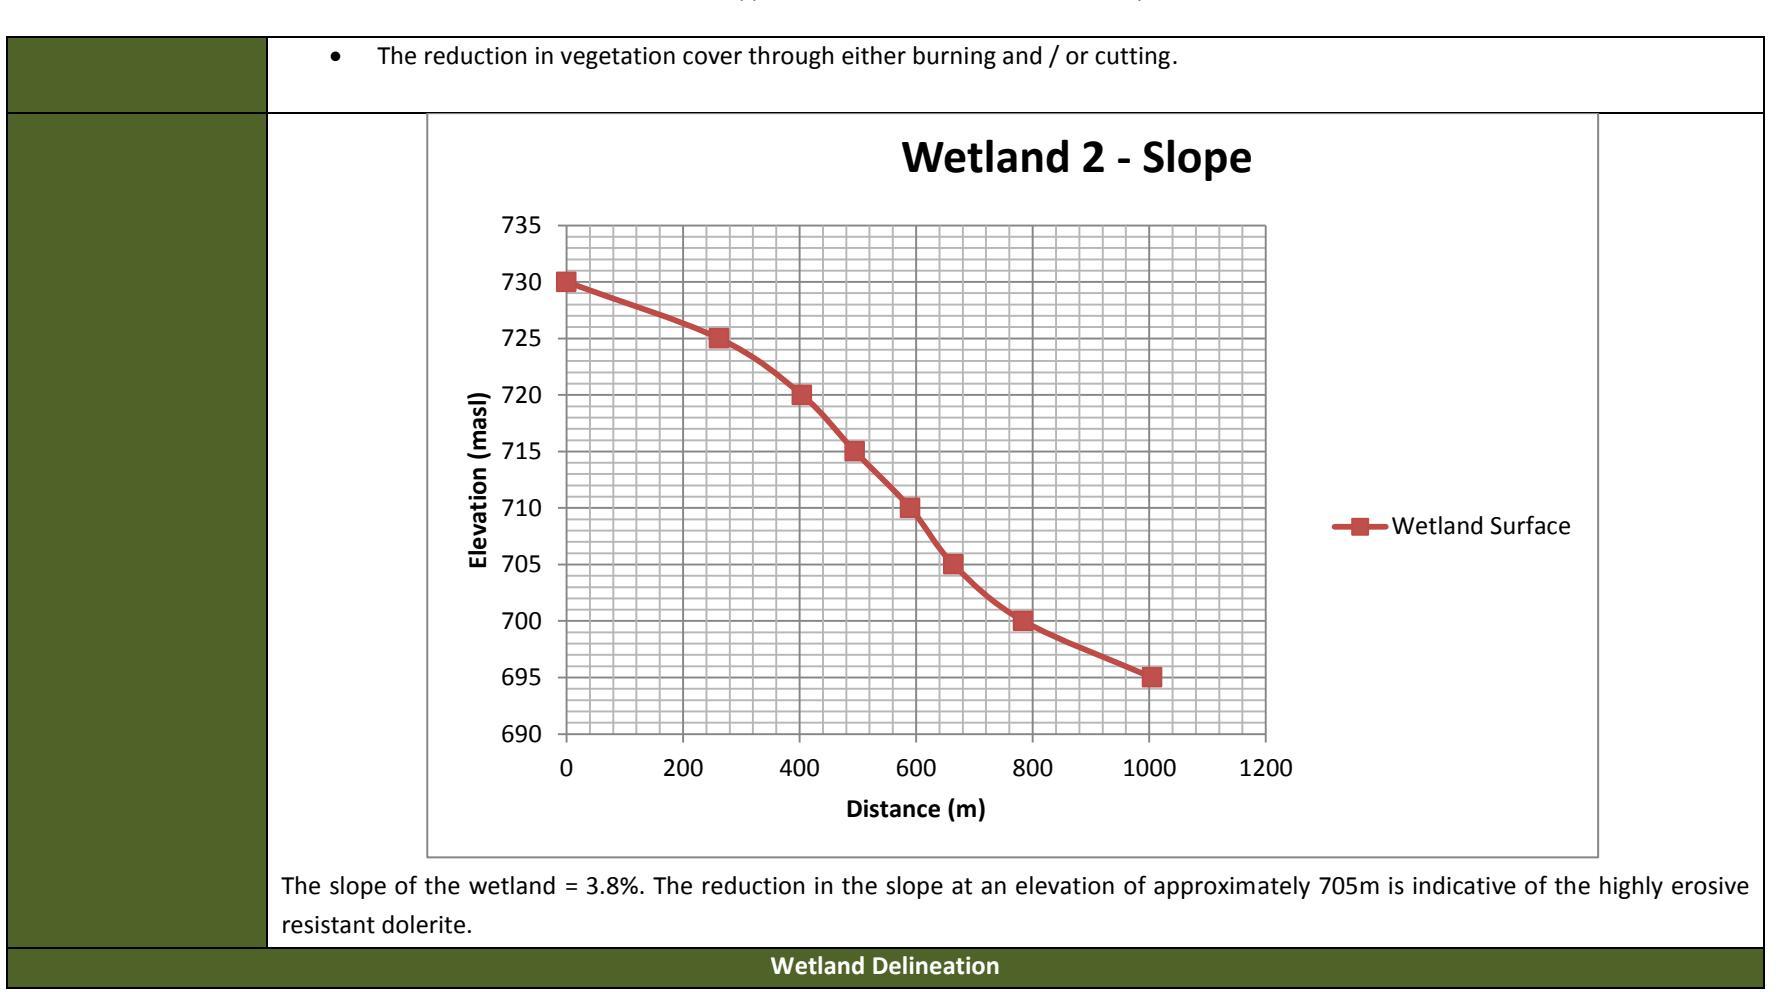
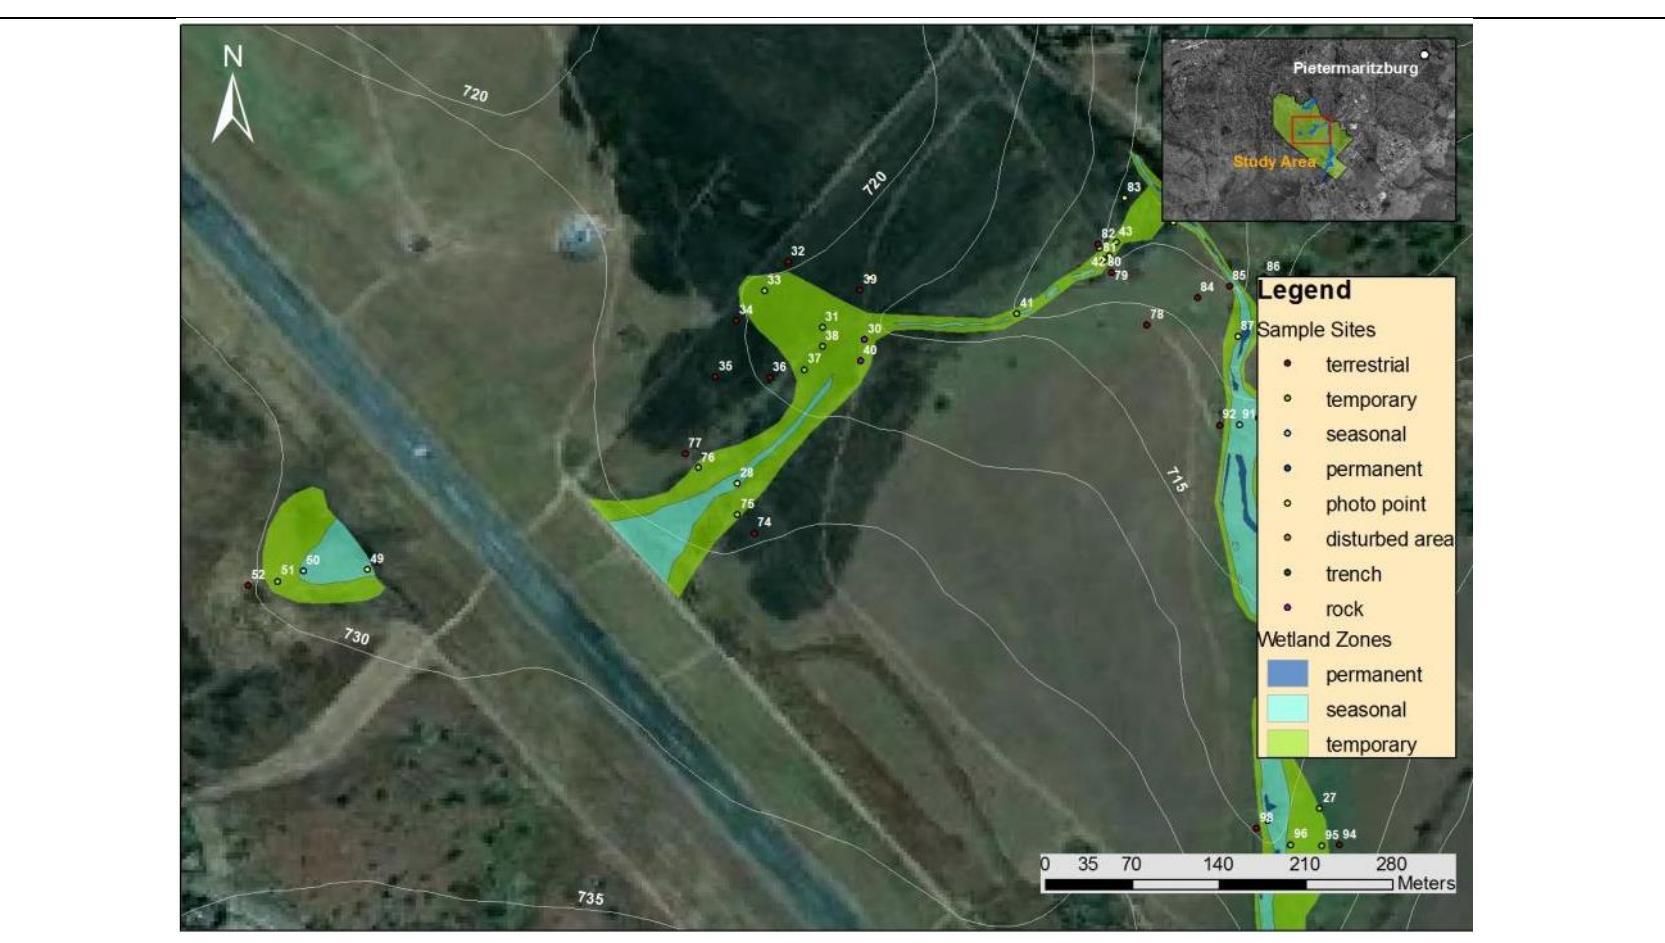
Wetland 2	W2 – Disturbed Valleyhead / Hillslope Seep linked to a Channel

Wetland 2 is a disturbed valleyhead / hillslope seepage wetland, which has been transformed through anthropogenic activities, including but not limited to:

- The construction of the Oribi airport runway directly through the wetland upper portion of the wetland;
- The canalization of the wetland downstream of the culverts under the runway;
- The removal of wetland soils within portions of the wetland (i.e. particularly upstream of the runway); and

Refer to the *Appendix* for a list of characteristics for each of the sample sites identified in the delineation map. Disturbances to the vegetation (i.e. recently burnt) restricted the accuracy of the delineation. A brief site visit will need to be conducted during optimal conditions (i.e. spring / summer) to verify the findings from this initial delineation.

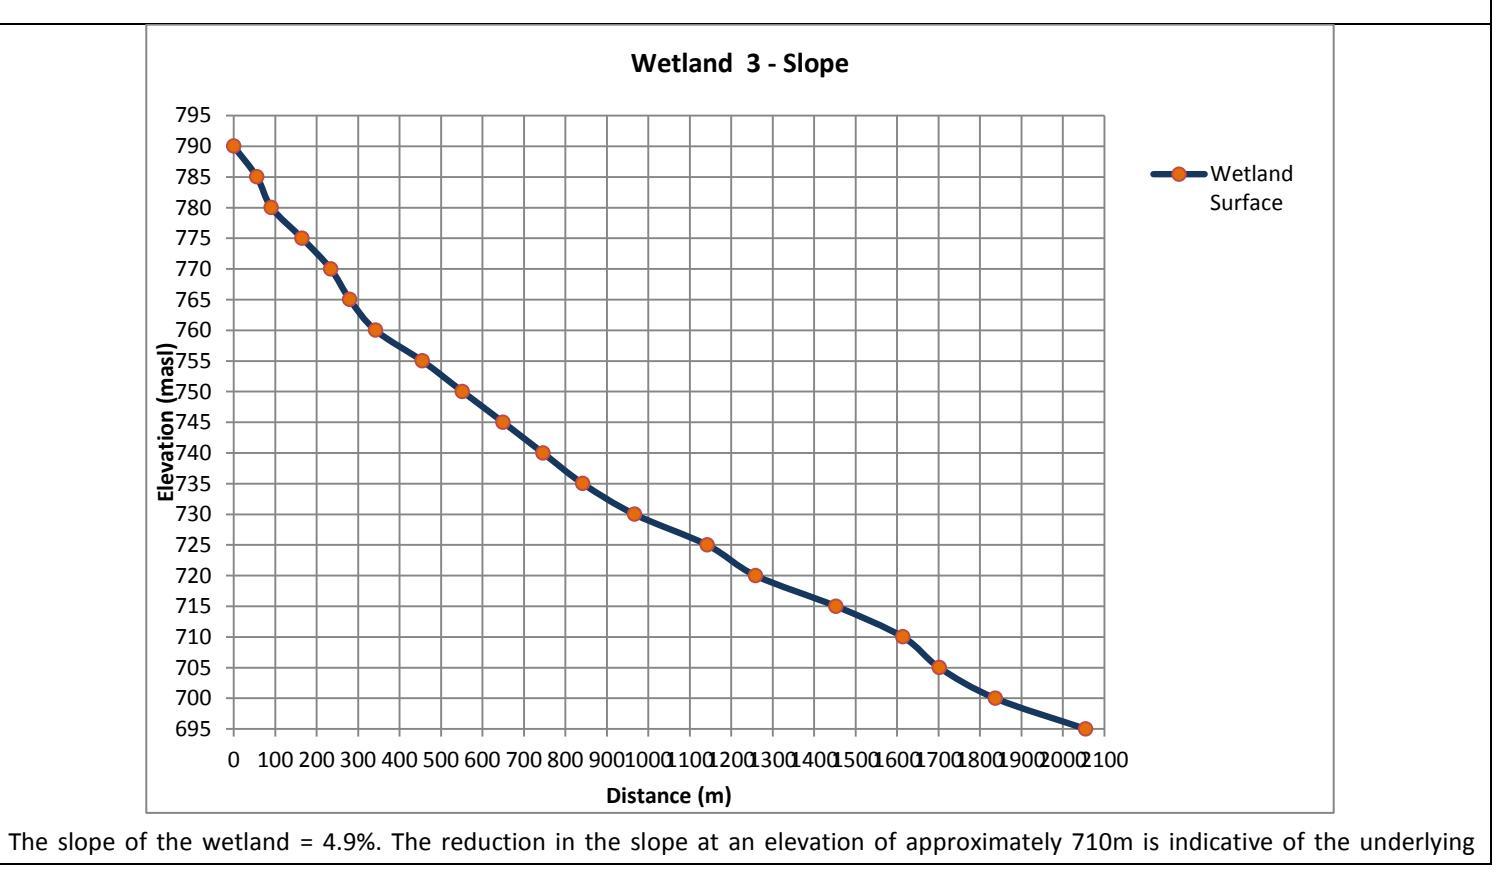
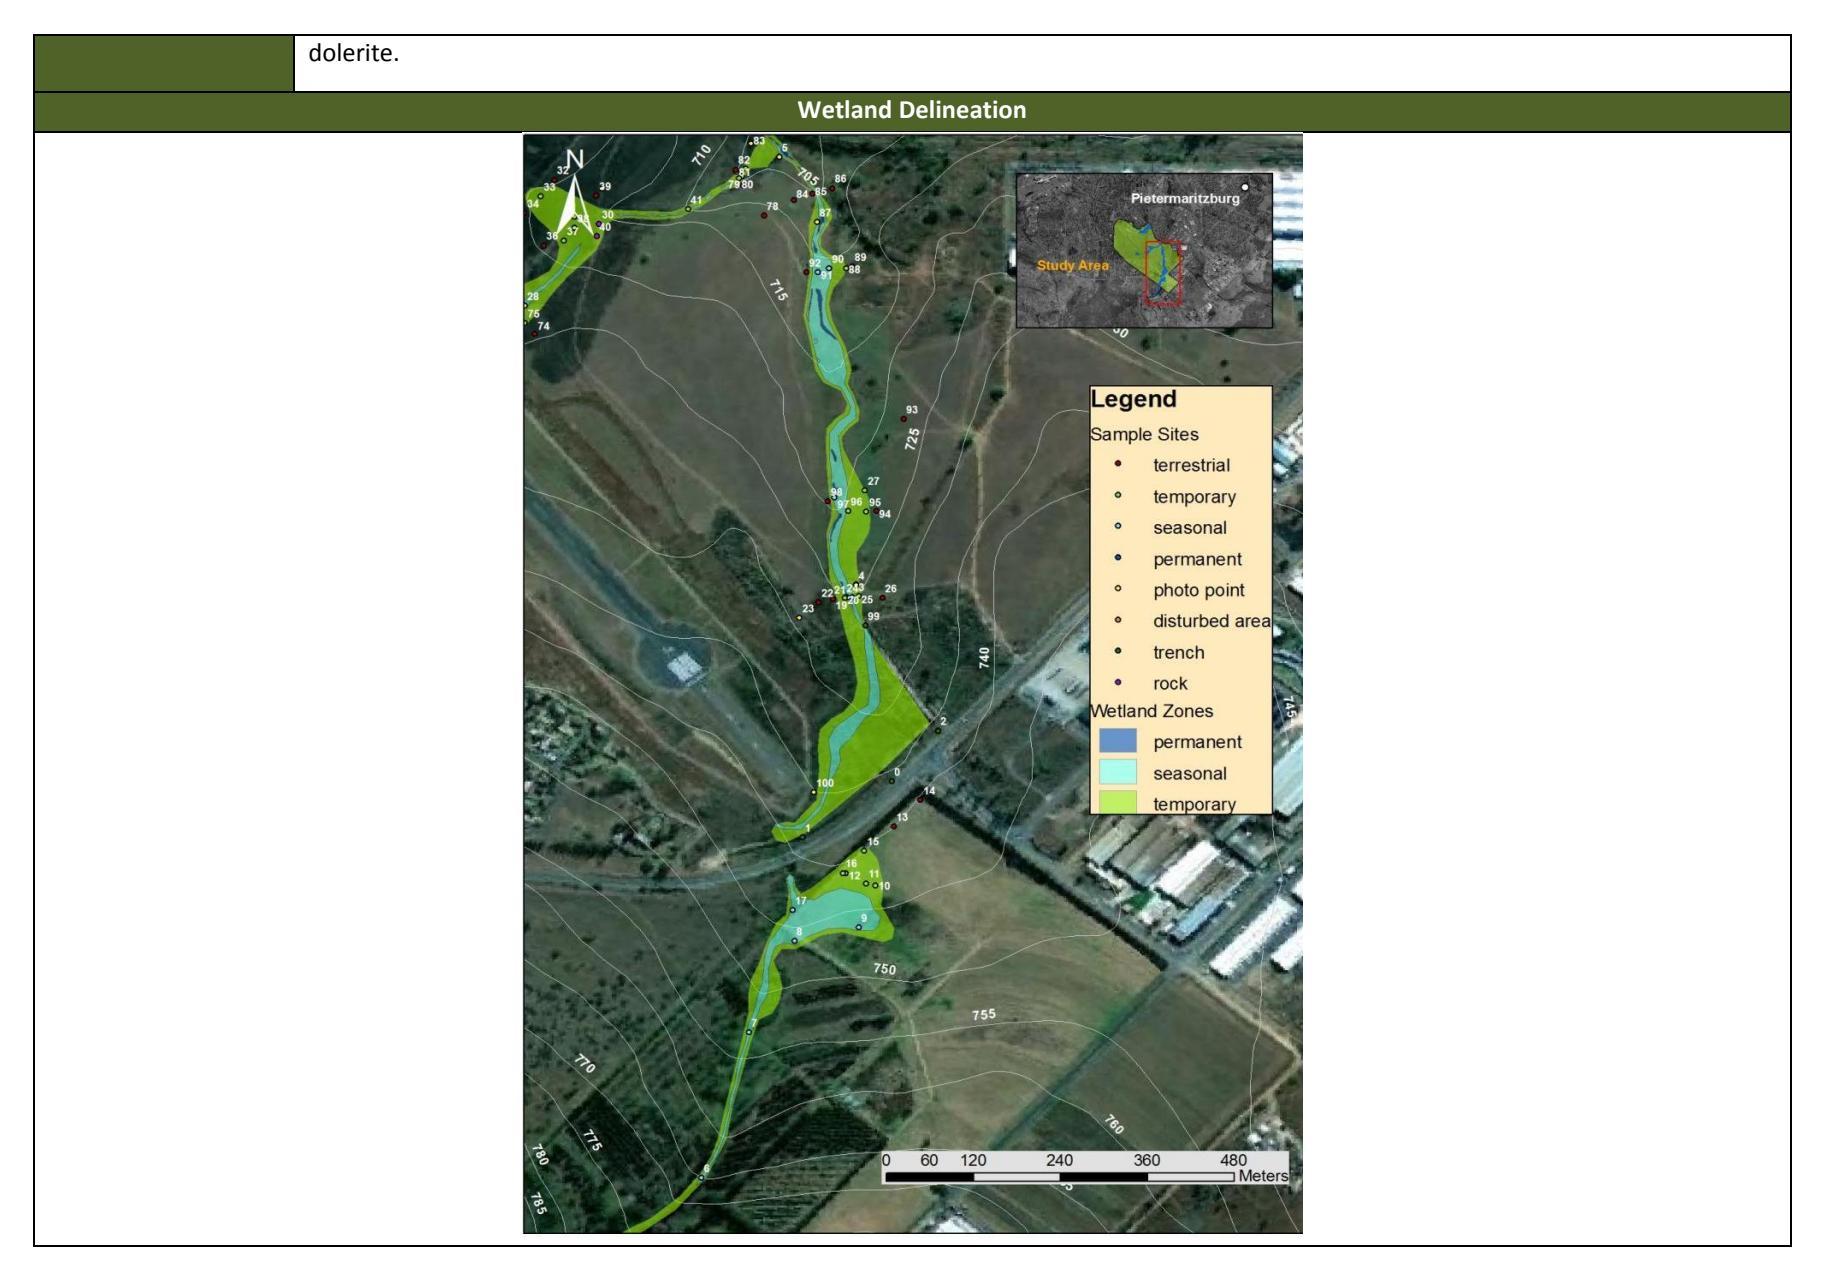
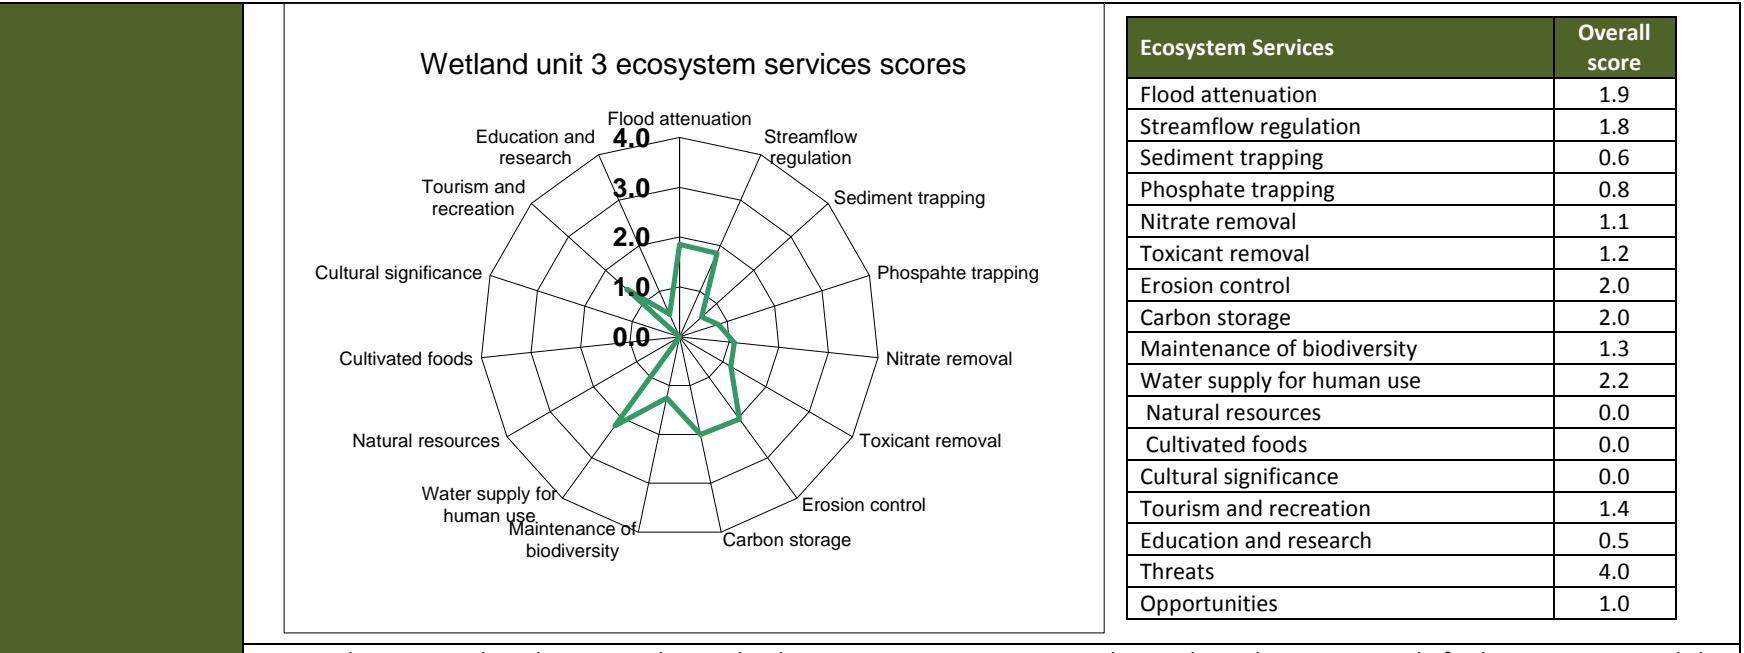
Wetland 3	W3 – Valley bottom with a channel							
	Wetland 3 is a disturbed channelled valley bottom wetland, which has been largely transformed through anthropogenic activities,

- Farming activities in the catchment and the upper reaches of the channel. These include the converting of wetland areas to pastures and clearing for the cultivation of various crops;
  A tar road (Gladys Manzi), which cuts through the top portion of the wetland;
  - A light industrial area within the catchment. Stormwater runs directly into the wetland;
  - Deep trenches have been dug for water pipelines adjacent to the tar road. These trenches run directly through the top portion of the wetland and also along it;
  - The dumping of rubble and litter within the wetland, primarily downstream of the tar road and the trenches;
  - Alien vegetation; and
  - The construction of a railway bridge, which has resulted in a 'pinch' in the wetland, i.e. the toe of the wetland.

Refer to the Appendix	Refer to the Appendix for a list of characteristics for each of the sample sites identified in the delineation map.							
Wetland Health / PES								
Indicator	Score	Description						
Hydrology	9.5	Critically modified: The volume of water entering the wetland has been significantly increase through inter catchment						
		transfer of water to irrigate at Ukulinga farm, which is at the state of the system. There is also extensive stormwater						
		runoff from harden surfaces in the catchment, i.e. primarily the light industrial area and the tar road. Water flow is						
		restricted to culverts running under Gladys Manzi road.						
Geomorphology	6.6	Seriously modified: The complete width of the wetland directly downstream of Gladys Manzi road has been trenched. A						
		portion of the eastern boundary of the wetland, directly downstream of the road has also been trenched. These trenches
